Public Works Facility

Description and Observations

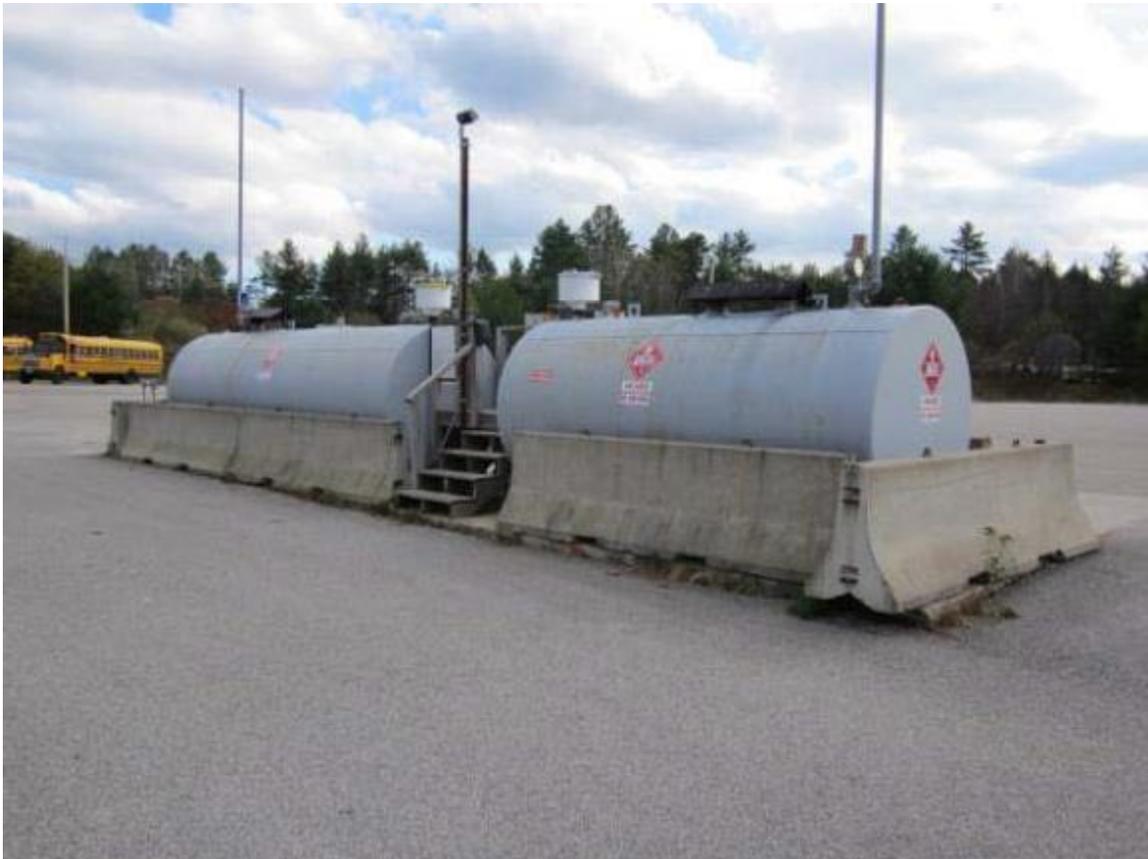
Other facilities located on the lower level include storage racks along the southwest edge of pavement and aboveground diesel and gas tanks just south of the garage. These tanks are also used by the School District for the buses and, at 3,000 and 2,000 gallons respectively, are undersized. They were originally intended to be used "temporarily" until new tanks of adequate size could be obtained.

- There is insufficient equipment storage and maintenance space, including insufficient number of garage bays.
- The existing diesel and gas storage tanks (which are also used by the school buses) are inadequately sized and were intended as a “temporary” arrangement. A complete packaged system with larger tanks is desired.

Civil Photo 8 - The Diesel and Gas Tanks

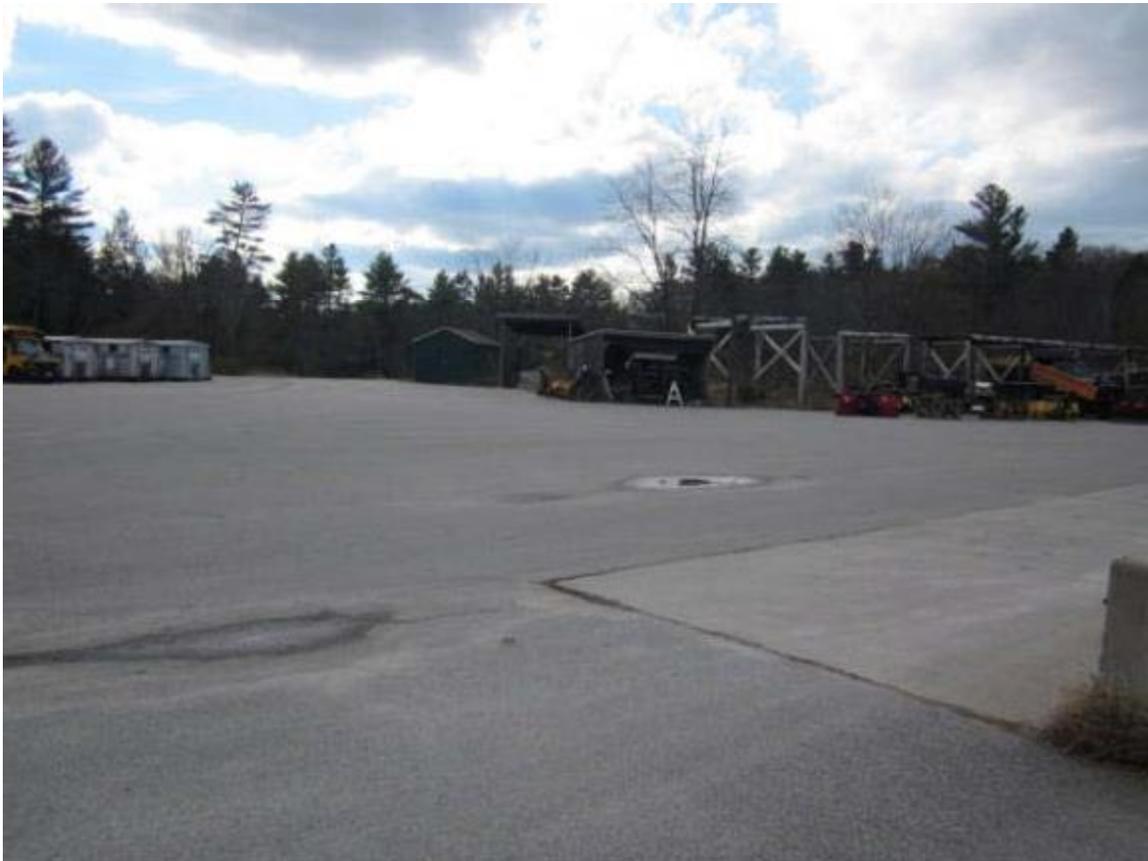
Access to the outdoor storage yard is via a gravel drive off the southerly corner of the maneuvering area. Three recycling containers (“silver bullets”) are located in this area. Their location present somewhat of a problem for the facility because they allow public access over the entire facility. The silver bullets, and the fact that the site is shared by the School District, complicate the issue of security/restricting access to the facility.

Civil Photo 10 - Note the Recycling Containers at the Southerly Corner of the Maneuring Area

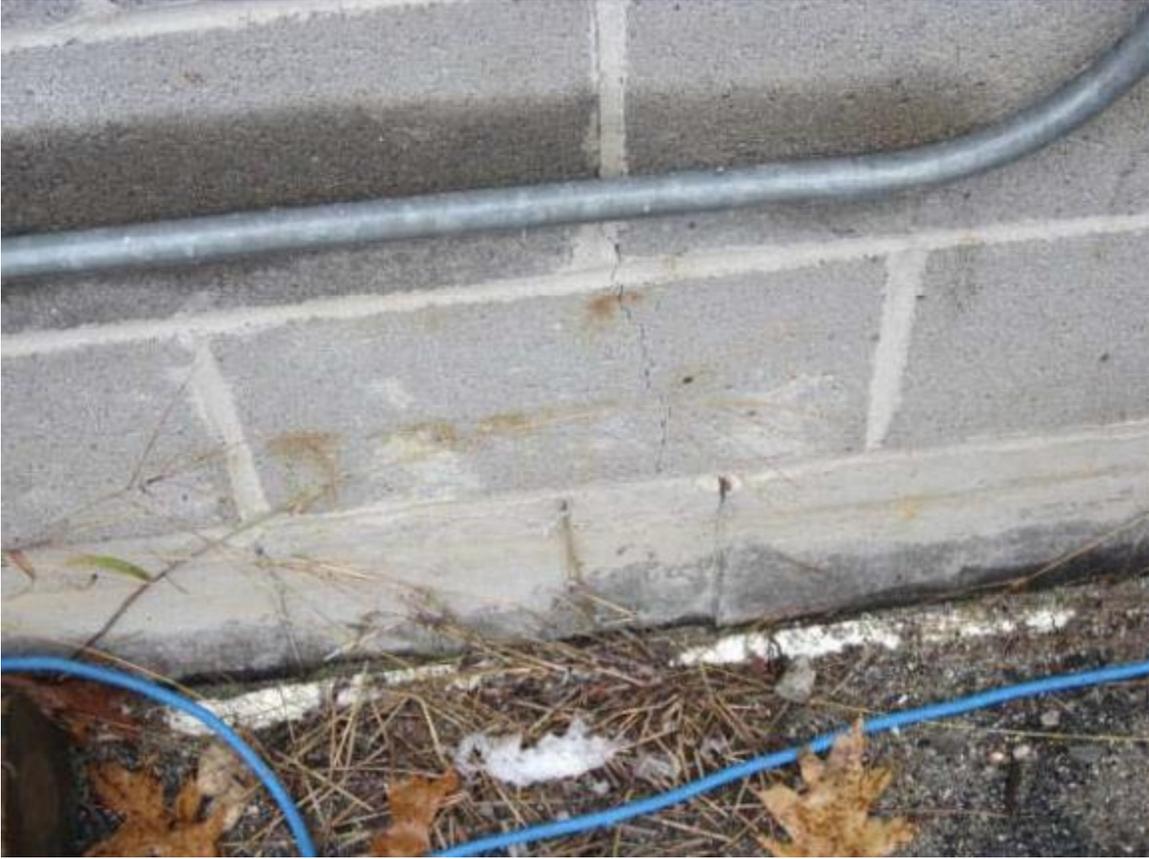
Concrete masonry walls are used to support the wood trusses. The original construction plans did not indicate if the walls contained vertical reinforcing steel. Based on this it is doubtful that the walls would have sufficient capacity to resist current building code requirements. Along the west wall there was cracking in the masonry that could be visible on both the exterior and interior sides of the wall, which is a possible indication of differential settlement of the building. Refer to Structural Photos 1 and 2. There

Structural Photo 1 - Crack at Exterior Side of Masonry Wall

Repair and seal crack at west masonry wall - \$800.

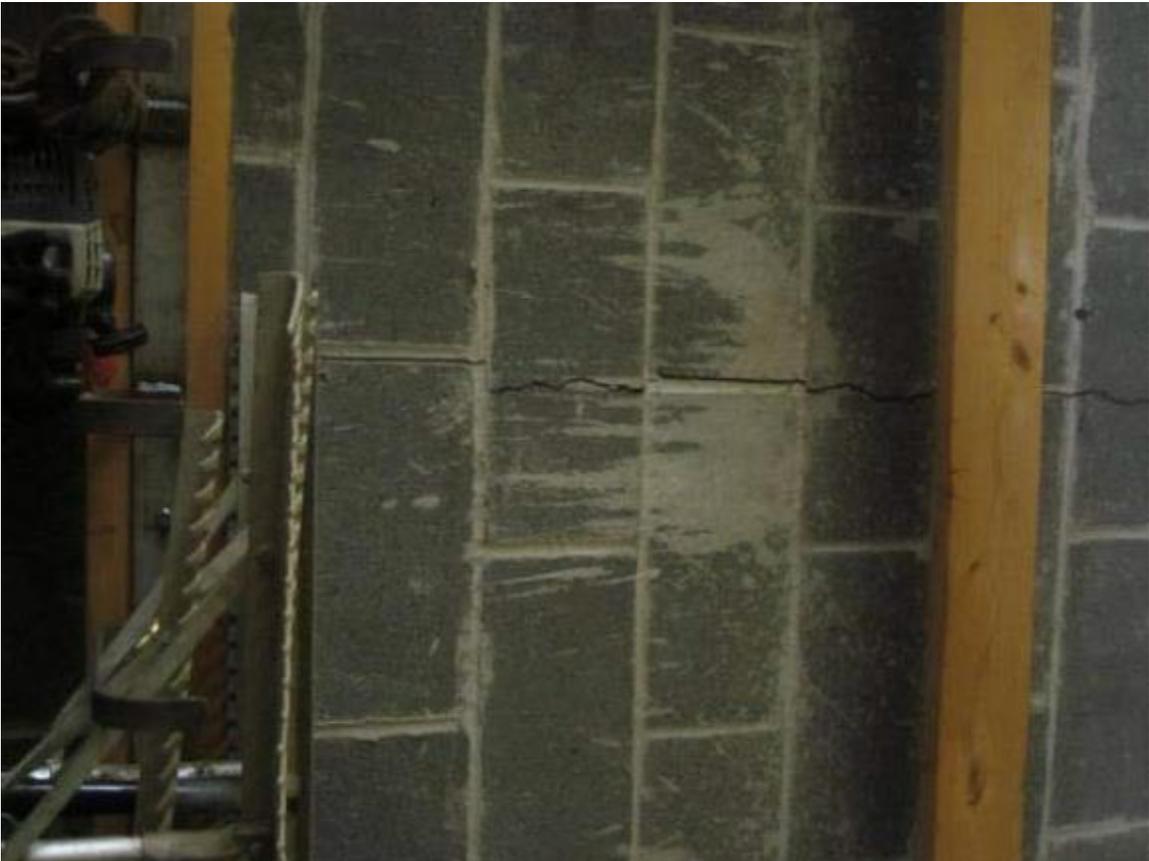
Structural Photo 2 - Crack at Interior Side of Masonry Wall

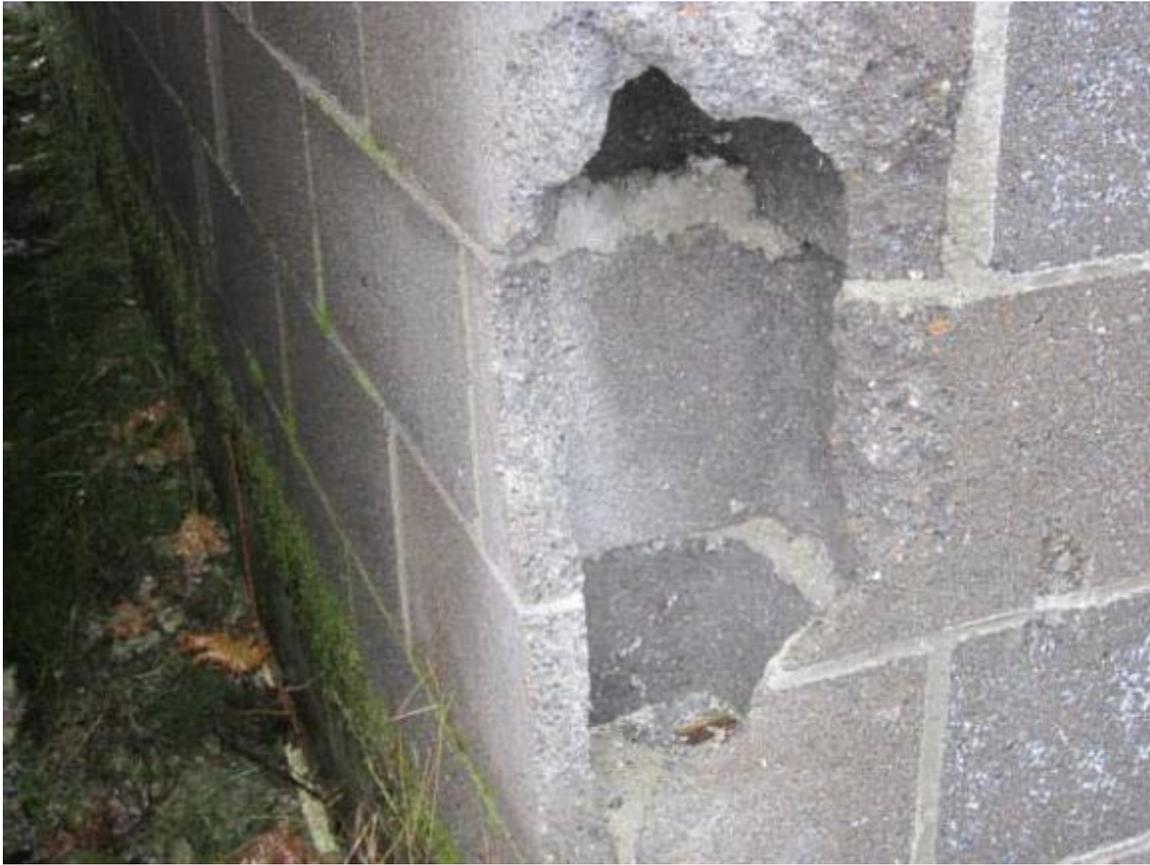
was a section of masonry that was damaged, at the North West corner, due to a vehicle impact. Refer to Structural Photo 3.

Structural Photo 3 - Damaged Corner Due to Vehicle Impact

Overall the structure is in average condition with the exception of the items noted above. It is recommended that the damage masonry at the North West corner be repaired. Should additional roof insulation be provided as part of future renovations projects be added a structural analysis of the roof structure would be recommended. It is also recommended that the cracking at the west wall be monitored to determine if there is any movement in the building as well as sealing and repairing the crack.

Repair damaged corner at northwest corner of building - \$500.

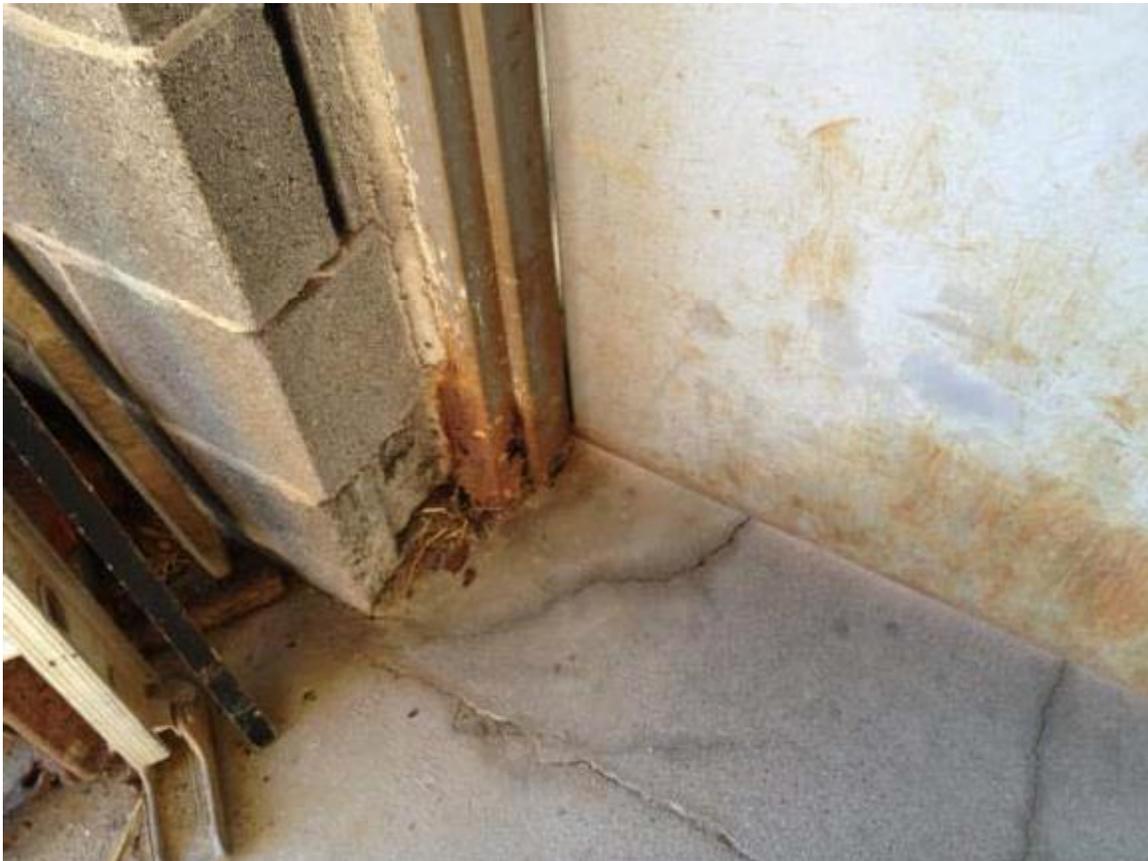
Architectural Photo 11 - Rusted Door and Frame

Doors between sections of maintenance bays have fire ratings but are missing latches or closers. These doors and the exterior door on the west end of the building have rusted metal frames. Replace doors, frames and hardware. \$3,750

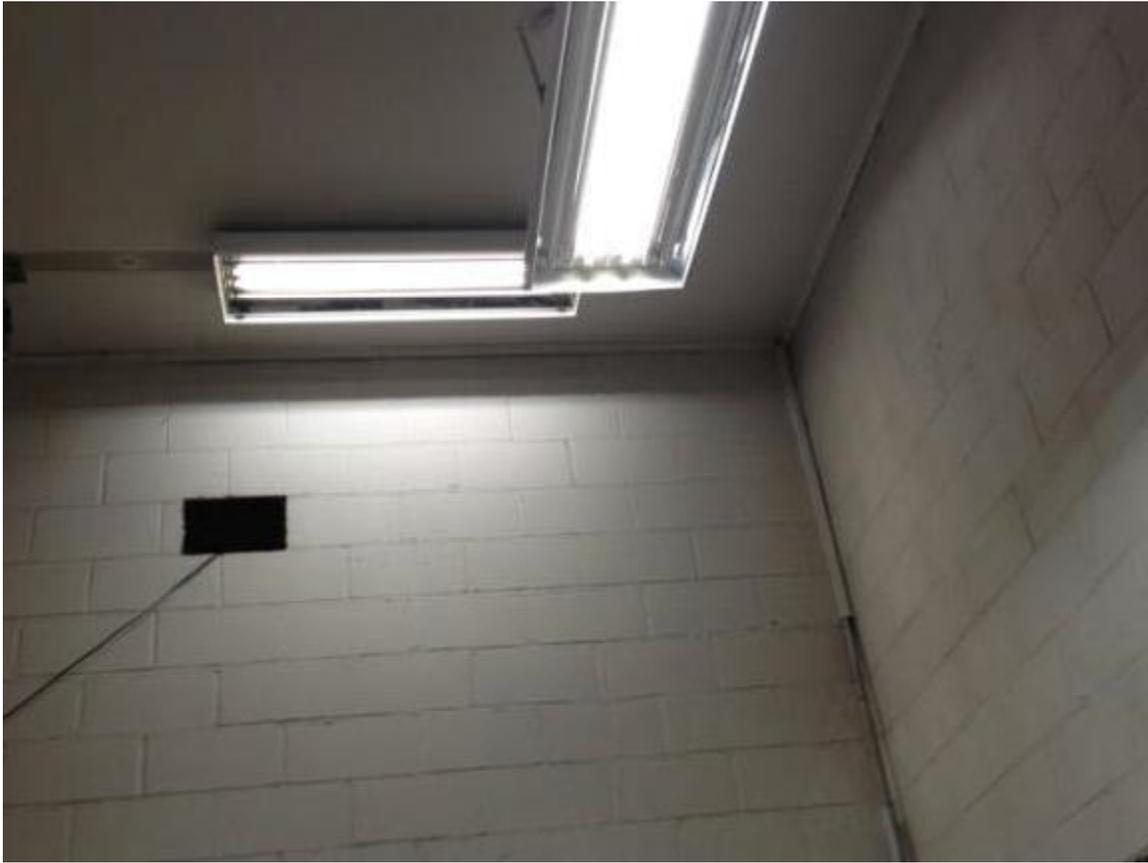
The large ground level storage area in the end two bays appears to be unheated, as is the upper level storage area created over the toilet rooms. In the upper storage room it was noted that a CMU block has been removed in the wall to the repair bays and a manually operated fan is placed on a shelf in front of the opening. It appears that this fan is run manually during very cold periods to pull warm air from the repair bays into the upper storage room, but the fan was not running at the time of the site visit.

Architectural Photo 12 - Opening in Fire Rated Masonry Wall

The enclosed space within the School District bays is designed to be fire rated. The masonry wall that separates this area from the adjacent bays has an opening where a concrete block is missing. Fill opening in masonry wall. \$300

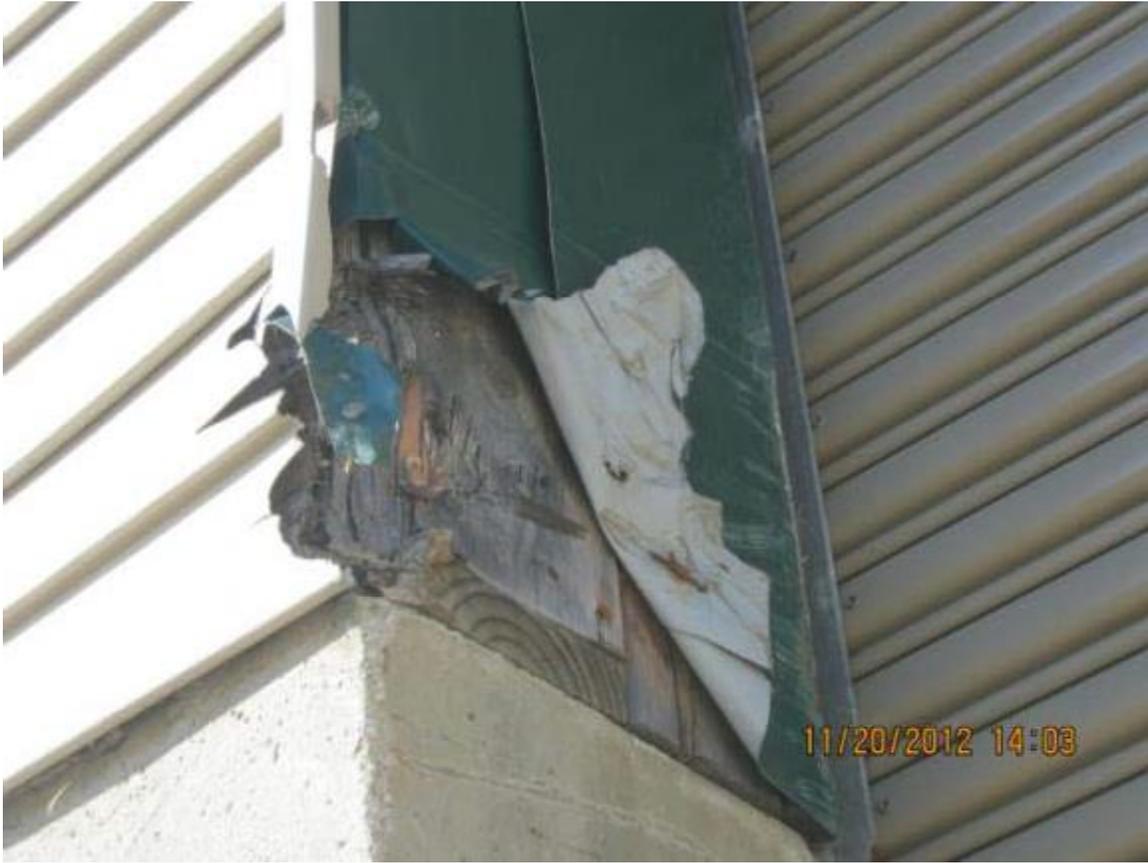
Architectural Photo 16 – Damaged Aluminum Trim

Sections of the salt shed roof panels and aluminum trim are damaged. The entrance door, frame and trim are severely corroded. Repair roofing, replace trim and replace door, frame and hardware. \$2,500

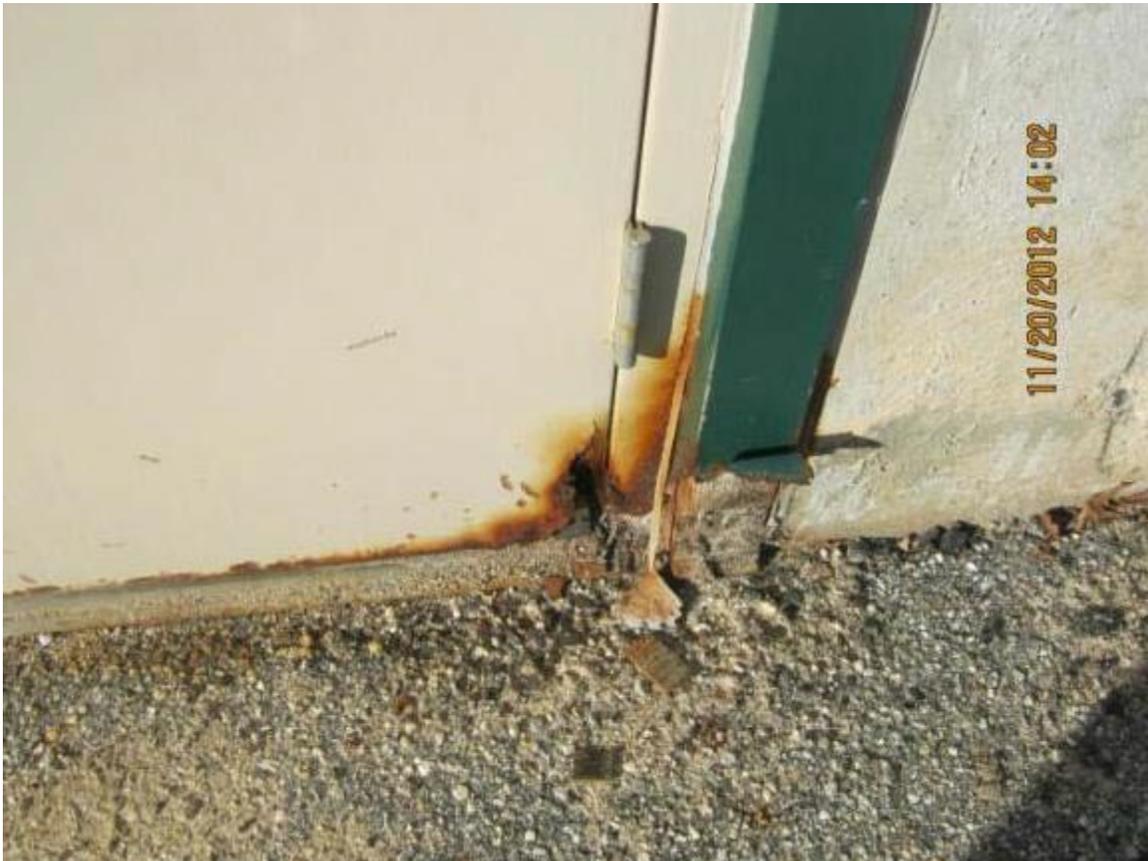
Architectural Photo 17 – Rusted Door and Frame

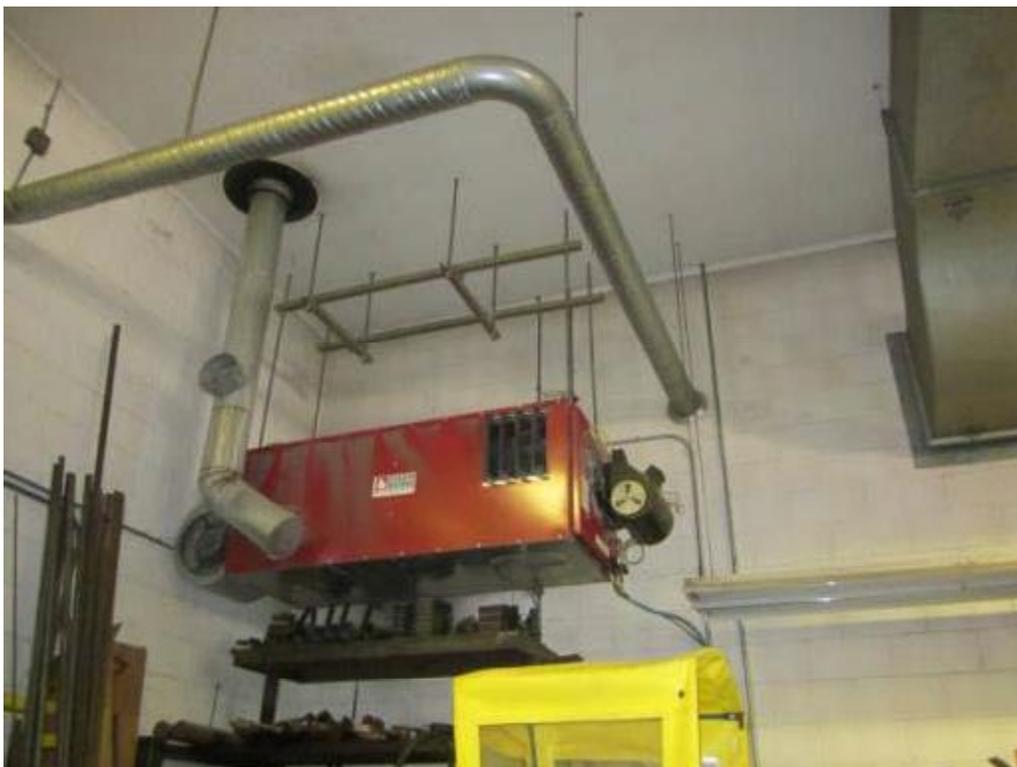
appears to be in poor to fair condition and is probably beyond its useful expected service life. This unit burns clean heating oil which is delivered to and stored in a large oil storage tank on the floor below. This oil tank is not interconnected with the other oil tanks, and heating oil deliveries are deposited here. An oil fill line as well as a vent line extend out through the rear wall of the building. A galvanized steel gas fire extends through the roof.

Mechanical Photo 4 - Secondary Suspended and Ducted Oil-Fired Heater which Burns Clean Oil Only in Public Works Area

The secondary clean oil-fired furnace for the public works maintenance bays appears to be original (from 1980) and is beyond its expected useful service life of 20 years. Replacement of this unit should be scheduled within the next 5 years to prevent unexpected failure. The total replacement cost for this should be approximately \$8,750 based on a 400 MBH unit.

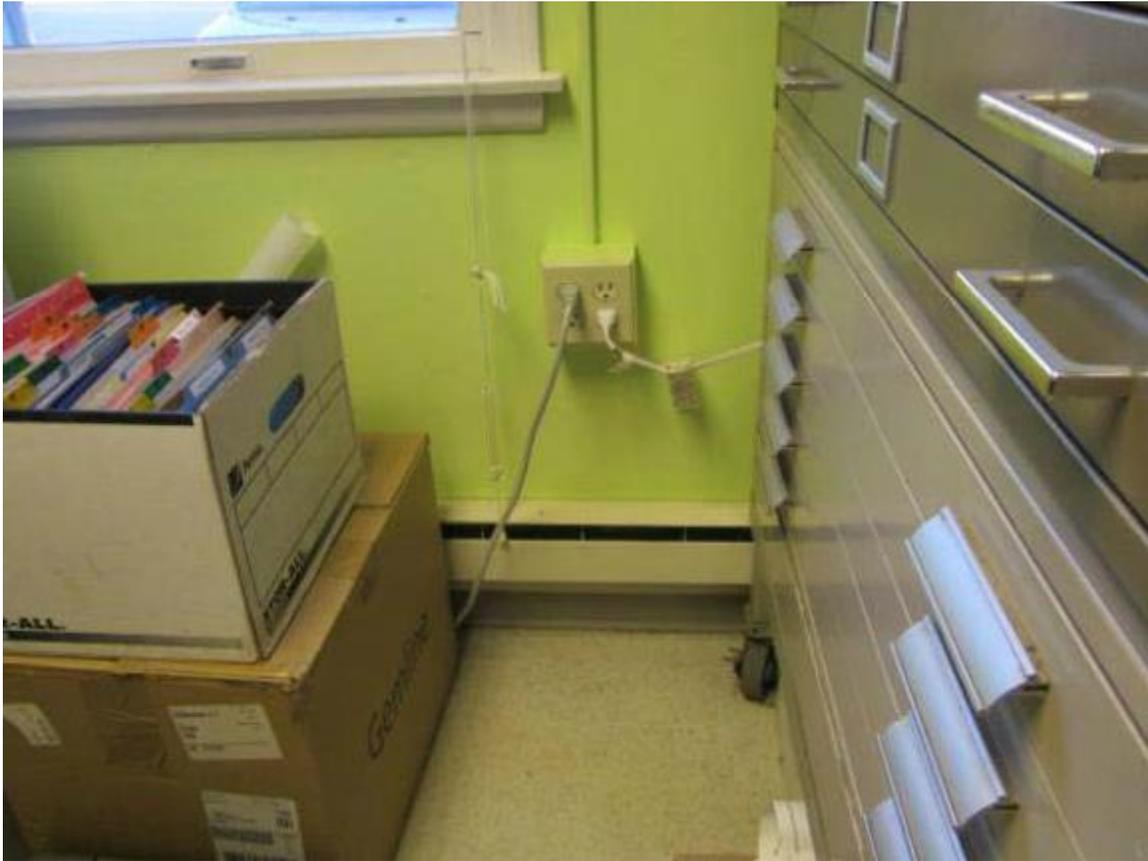
The two story office and support portion of the building is heated by various electric terminal heating units. Most of the upper level spaces are provided with sections of electric baseboard. The installed baseboard does not appear to be adequate to heat all of the spaces as several additional portable electric space heaters were noted as well. It was also noted that furniture and file cabinets are pushed up against the baseboard in some spaces. This will restrict the heat output of the element by restricting the airflow required for convective heating. Record drawings for the building are dated 1980 and electric baseboard appears to be original dating from that time, making it well past the expected useful service life of twenty years.

Mechanical Photo 10 - Upper Level Electric Baseboard Heater in Public Works Area - Partially Blocked

The public works office and support area electric baseboard and wall heaters appear to be original to the building, except for two units on the lower level and they are beyond their expected useful service life of 20 years. Replacement of this equipment should be scheduled within the next 5 years to prevent unexpected failure. The total replacement cost for this should be approximately \$2,000.

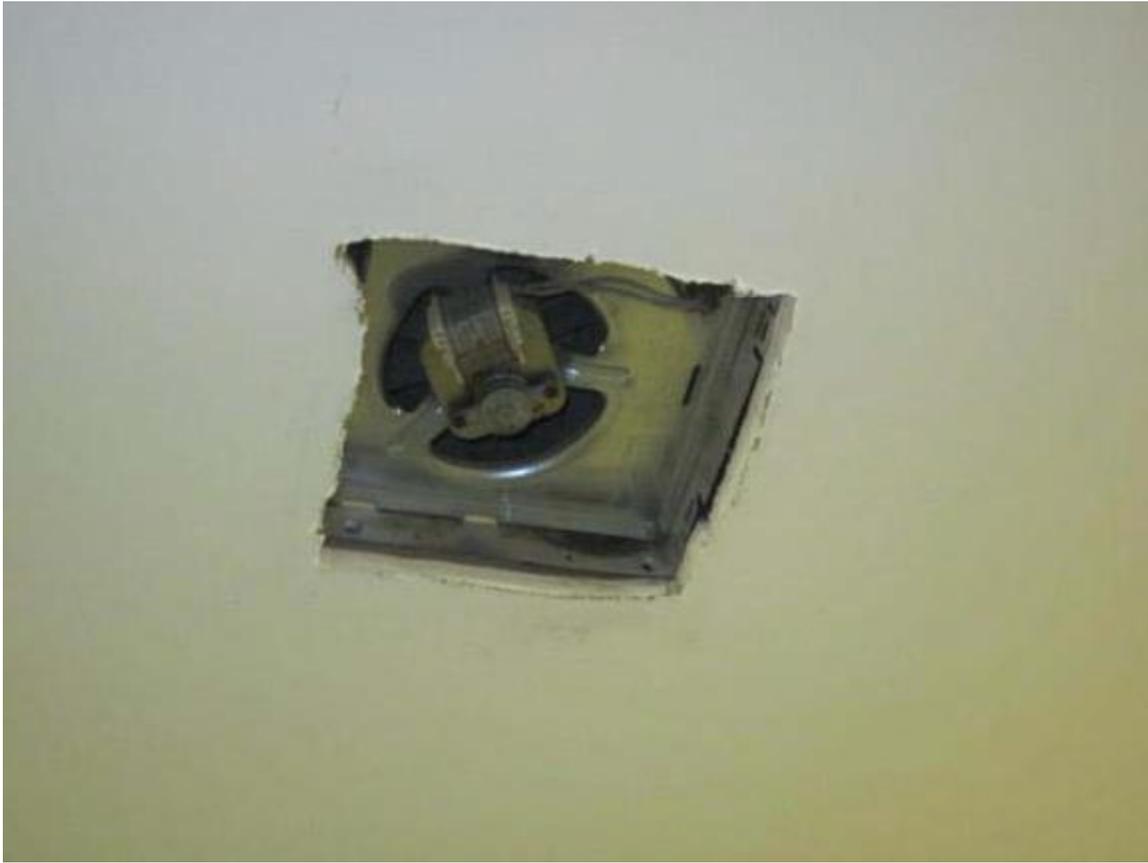
Each of the toilet rooms is provided with a ceiling mounted exhaust fan which is controlled by the room lighting occupancy sensor. The fans appear to be ducted to a common louvered vent in the rear exterior wall. It was noted that the fan exhaust grille is missing from the women's room fan and that the fan was not operational at the time of the site visit.

Mechanical Photo 18 – Inoperable Women’s Room Exhaust Fan

The School District women's toilet room exhaust fan should be removed and replaced with an operational fan if repairs cannot be made to make the existing fan operational again. The total replacement cost for this should be approximately \$450.

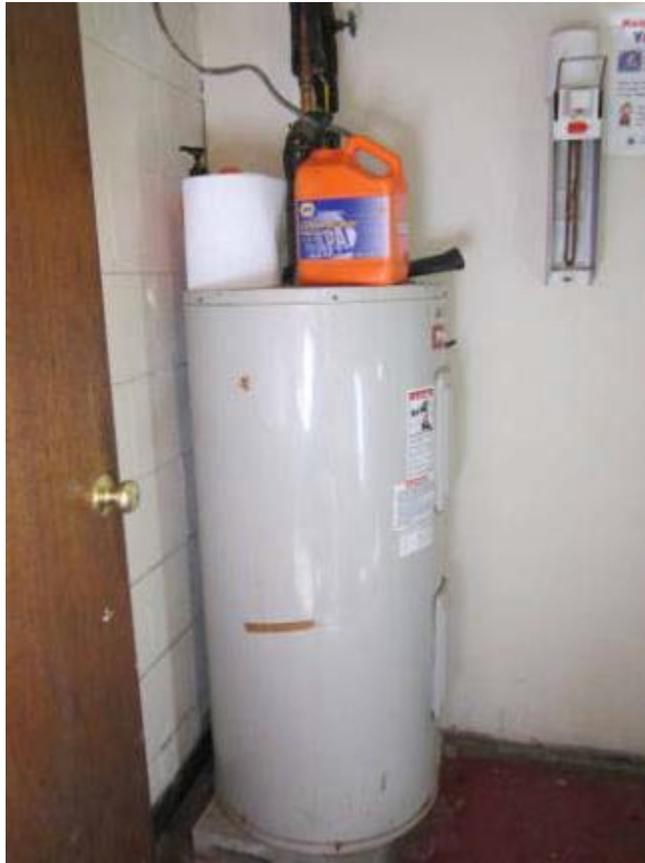
A 40-gallon electric hot water heater is located in the lower level toilet room and it appears to be in fair condition, although a bit oversized for the building load. There is no mixing valve installed on the system indicating that the hot water is being generated at the delivery temperature of approximately 115 deg F. Storing hot water at temperatures below 140 deg F has been found to promote the growth of Legionella bacteria.

Mechanical Photo 20 - Electric Domestic Hot Water Heater in Lower Level Toilet Room for Public Works Area

We recommend that a thermostatic mixing valve be provided on each of the three the domestic hot water supplies and that the electric water heater setpoints be raised to 140 deg F. This would result in a higher water storage temperature, preventing growth of Legionella bacteria. The total installed cost for providing three small mixing valves should be approximately \$2,700.

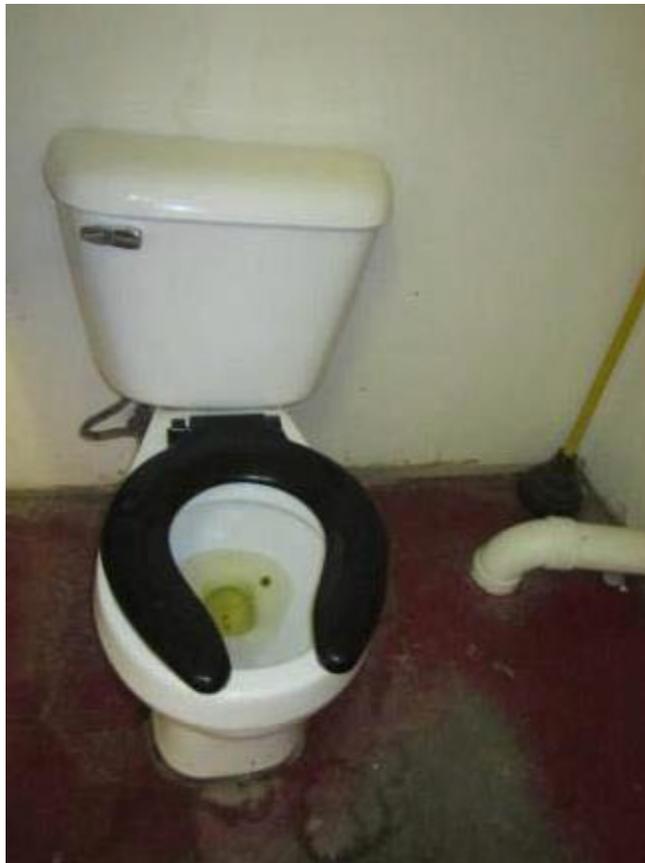
Plumbing fixtures in the Public Works areas of the building are very limited with only two toilet rooms and a lunch room, and no fixtures are located in the lunch room. The lower level toilet room has a floor mounted, white vitreous china, tank type water closet, a wall mounted white vitreous china urinal with manual flush valve, and a floor mounted plastic laundry tray. The urinal and laundry tray are in fair to good condition while that water closet is in poor condition. None of the fixtures are ADA compliant.

Mechanical Photo 21 - Lower Level Toilet Room Water Closet in Public Works Area - Poor Condition

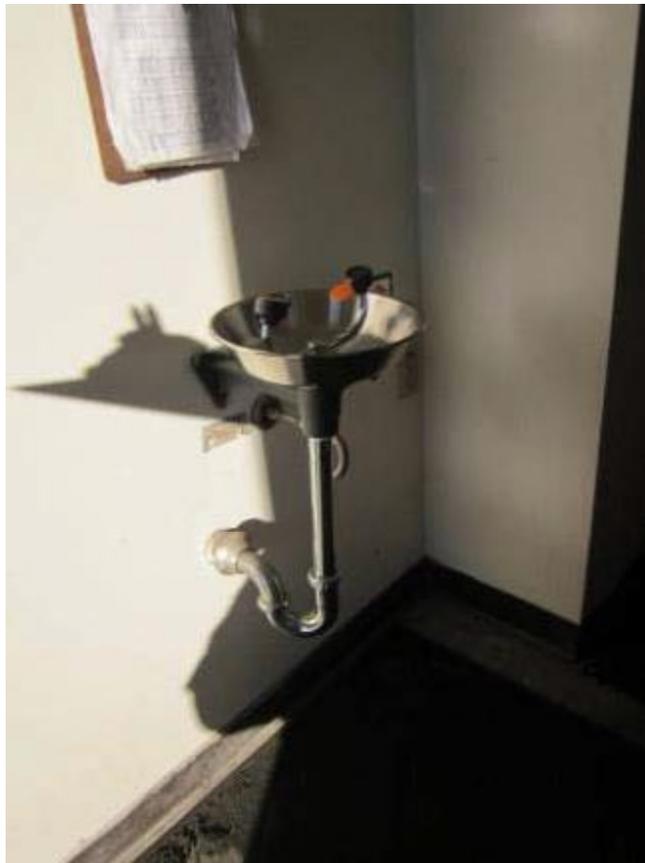
The final plumbing fixture in the Public Works area is a wall mounted stainless steel eyewash station located at the bottom of the stairwell. The eyewash appears to be direct connected to the sanitary system at the toilet room laundry tray on the other side of the wall. The installation does not appear to be provided with a thermostatic mixing valve in order to provide the tempered water supply required at the fixture by current safety standards.

Mechanical Photo 23 - Lower Level Stairwell Emergency Eyewash Station in Public Works Area

Neither the eyewash station in the public works stairwell nor the eyewash in the school bus repair bays is currently provided with a thermostatic mixing. Current safety standards require that the supply water temperature to emergency fixtures be "tepid" or around 85 deg F so that full flushing of eyes can occur. We recommend that a thermostatic valve be provided for both of these fixtures. The total installed cost for providing two thermostatic mixing valves should be approximately \$2,200.

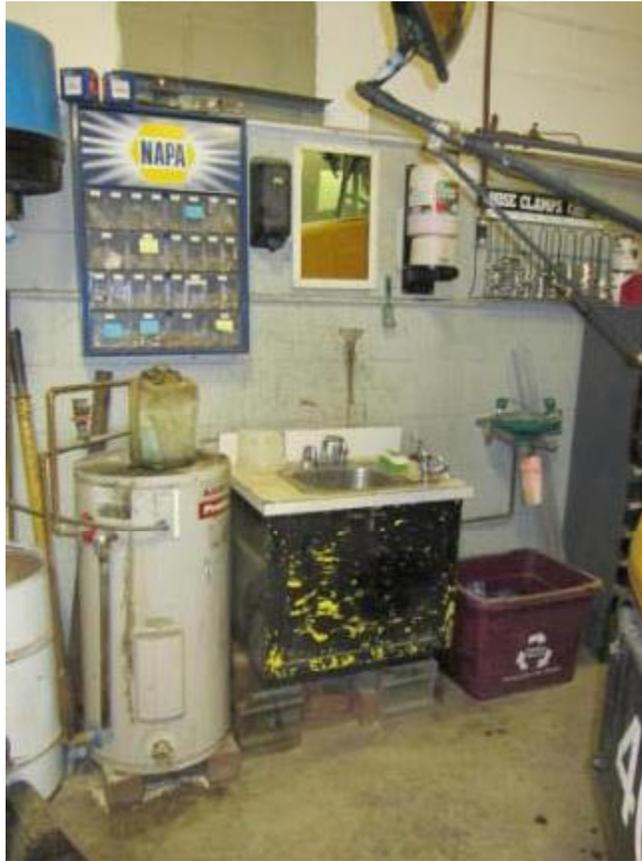
There is a small stainless steel hand sink with a side bubbler installed in a plywood cabinet located in the back corner of the school bus repair bays. On one side of the sink is a floor mounted, 20-gallon, electric hot water heater in poor condition and on the other side is a wall mounted emergency eyewash station. The domestic water for these fixtures comes from a hard pipe connection to a hose bibb which was originally on the exterior of the public works building. These fixtures are in poor condition.

It was noted that the eyewash station is also not provided with a thermostatic mixing valve as required by current codes. The eyewash was noted to be covered with a thick layer of duct which indicates that it has not been tested in quite a while. The eyewash drain is simply an open pipe, intended to drain onto the floor, but if currently operated it would fill the plastic recycling bin filled with rags currently placed below the eyewash.

Mechanical Photo 26 – Bus Bay Electric Water Heater, Sink and Emergency Eyewash

sink would become available from the water heater removal. The total installed cost for the water heater removal and the sink replacement should be approximately \$900.

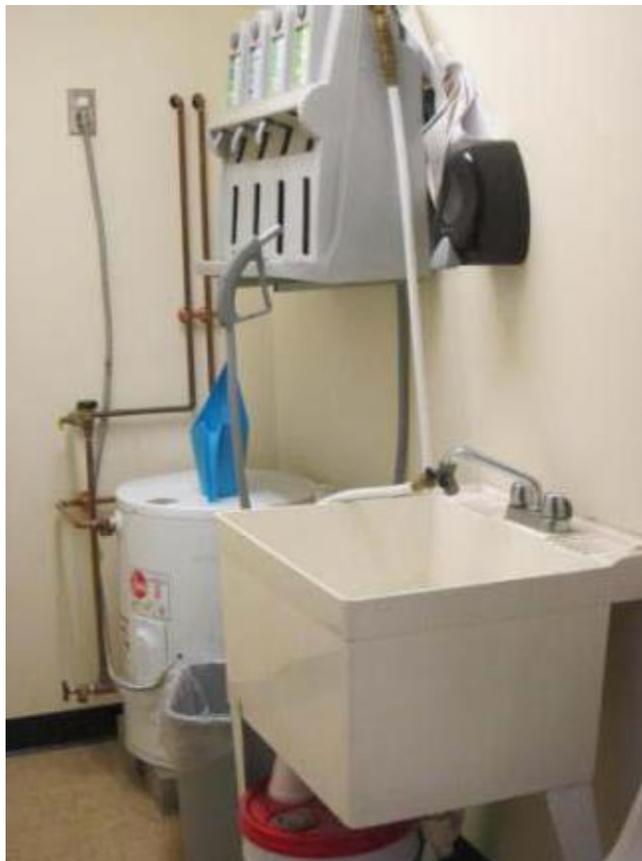
heater in good condition. Neither cold nor hot water piping exposed at the heater is insulated and no thermostatic mixing valve has been provided at this location either.

The service sink is a floor mounted plastic laundry tray which is currently only supported on two legs; the other two legs are lying on the floor below the sink. The sink faucet has a manual faucet and a swing spout. The faucet outlet is provided with a two-way manual splitter valve; one side is open for discharge and the second is a hose connection to the wall mounted detergent dispenser adjacent to the sink. It was noted that there is no vacuum breaker provided on the faucet, nor is there any type of backflow preventer to stop the detergent from siphoning back into the building domestic water system.

Mechanical Photo 27 – Electric Water Heater and Service Sink

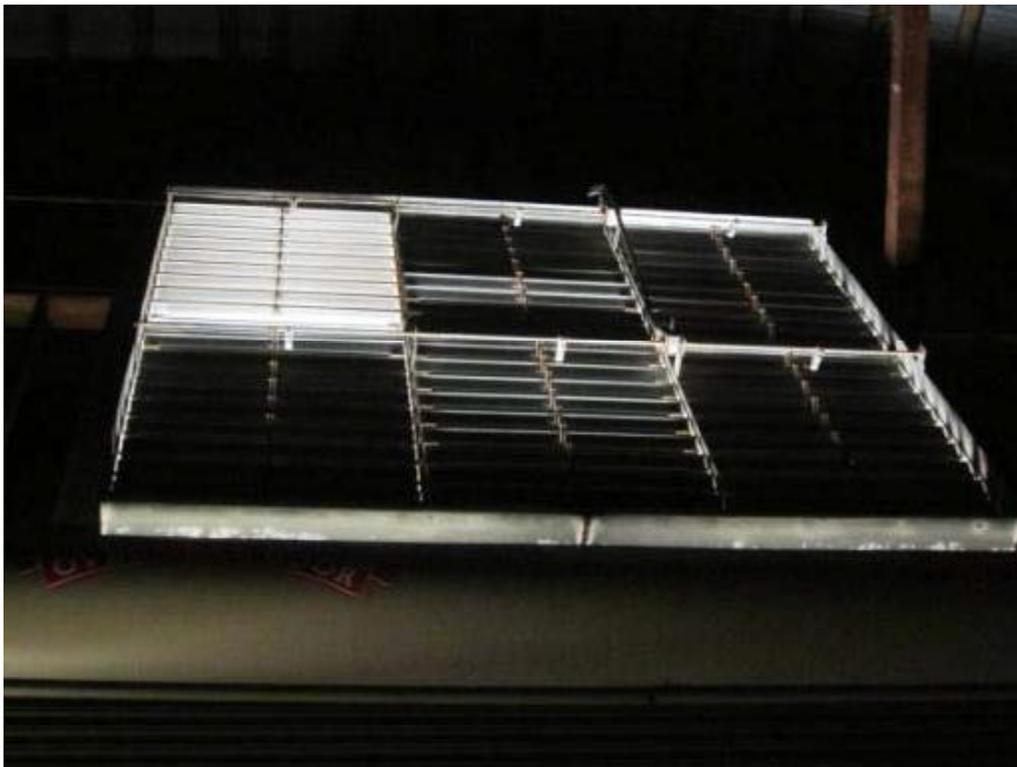
The salt shed is provided with a whole building ventilation system. A large air intake louver is located above the overhead door at the southeast end of the building, and a motorized damper is placed behind the louver. It was noticed during the walk through that the damper blades or axles are bent or damaged and several sections of the louver cannot fully close.

Mechanical Photo 29 - Sand Salt Shed Air Intake Damper - Sections Do Not Fully Close

At the salt shed, the automatic damper at the southeast air intake louver should be replaced so that it can fully close. A new louver should also be provided at the exhaust fan to help protect the fan from the elements, extending its service life. The total installed cost for a replacement intake damper and a replacement exhaust louver should be approximately \$1,575.

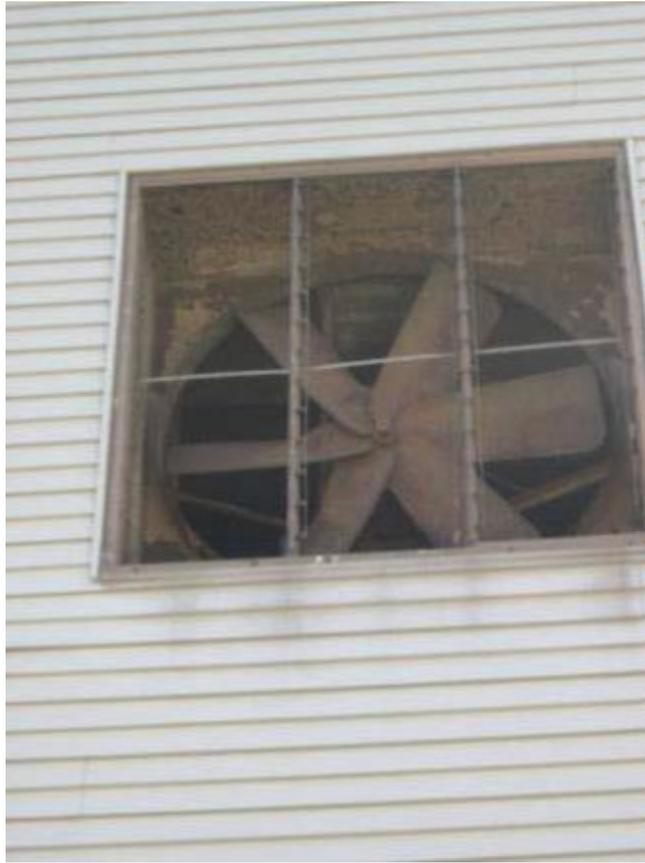
A large through wall exhaust fan is located at the northwest end of the salt shed and the fan is interlocked with the intake damper actuator. A large louver had initially been installed at the exhaust fan, but the louver is no longer in place. The blades of the exhaust fan are starting to rust, and without the louver in place, the fan is fully exposed to the elements.

Mechanical Photo 30- Sand Salt Shed Exhaust Fan - Protective Louver Missing
