# Donnabeth Lippman Park

## Master Plan

August 2012

**Mitchell  
& Associates**  
LANDSCAPE ARCHITECTS  
70 Center Street  
Portland, Maine 04101  
207-774-4427

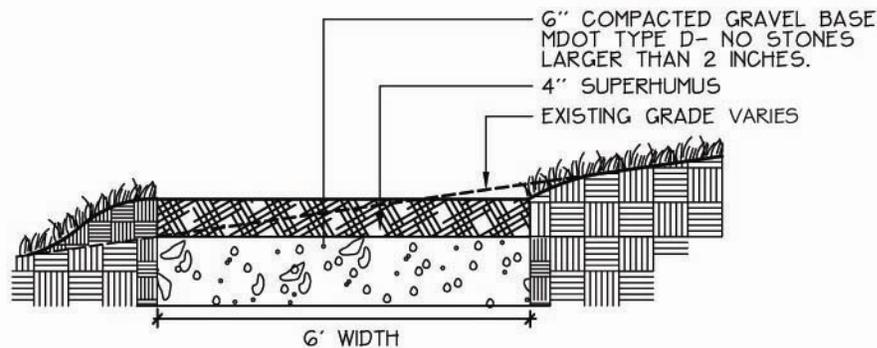
#### WOODLAND PATH

- Limb overhead branching to maintain a minimum ten (10) foot clearance.

- Provide a walking surface of “superhumus” or organic wood product material of equal quality and performance.
- Provide a compacted gravel base to provide a stable and uniform surface as necessary subject to existing soil conditions.

- Construction of all trail sections should limit disturbance to defined trail alignment and avoid disturbance of adjacent area. Use of small construction equipment such as a 'Bobcat' is recommended. In areas closest to existing trees, excavation should be limited, hand work as may be necessary to protect tree roots. Alternative is to provide gravel fill over root areas to avoid disturbance. No fill shall occur within the drip line of trees exceeding six inches.

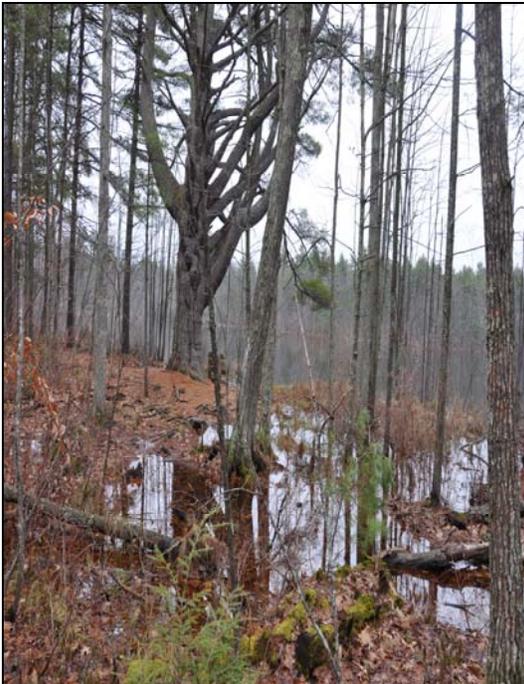
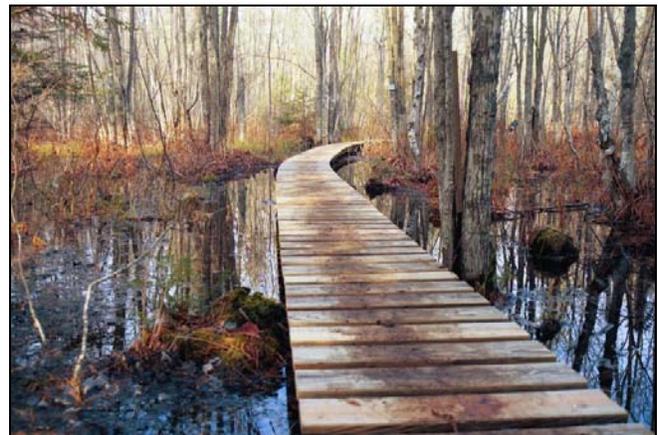
Location: The raised boardwalk trail will be field located to avoid removal of existing trees and desired understory. The trail should generally follow the alignment as shown on the concept plan through the areas that are currently impassible due to wet seasonal conditions.

- The raised boardwalk should be five (5) feet wide to minimize disturbance and cost.

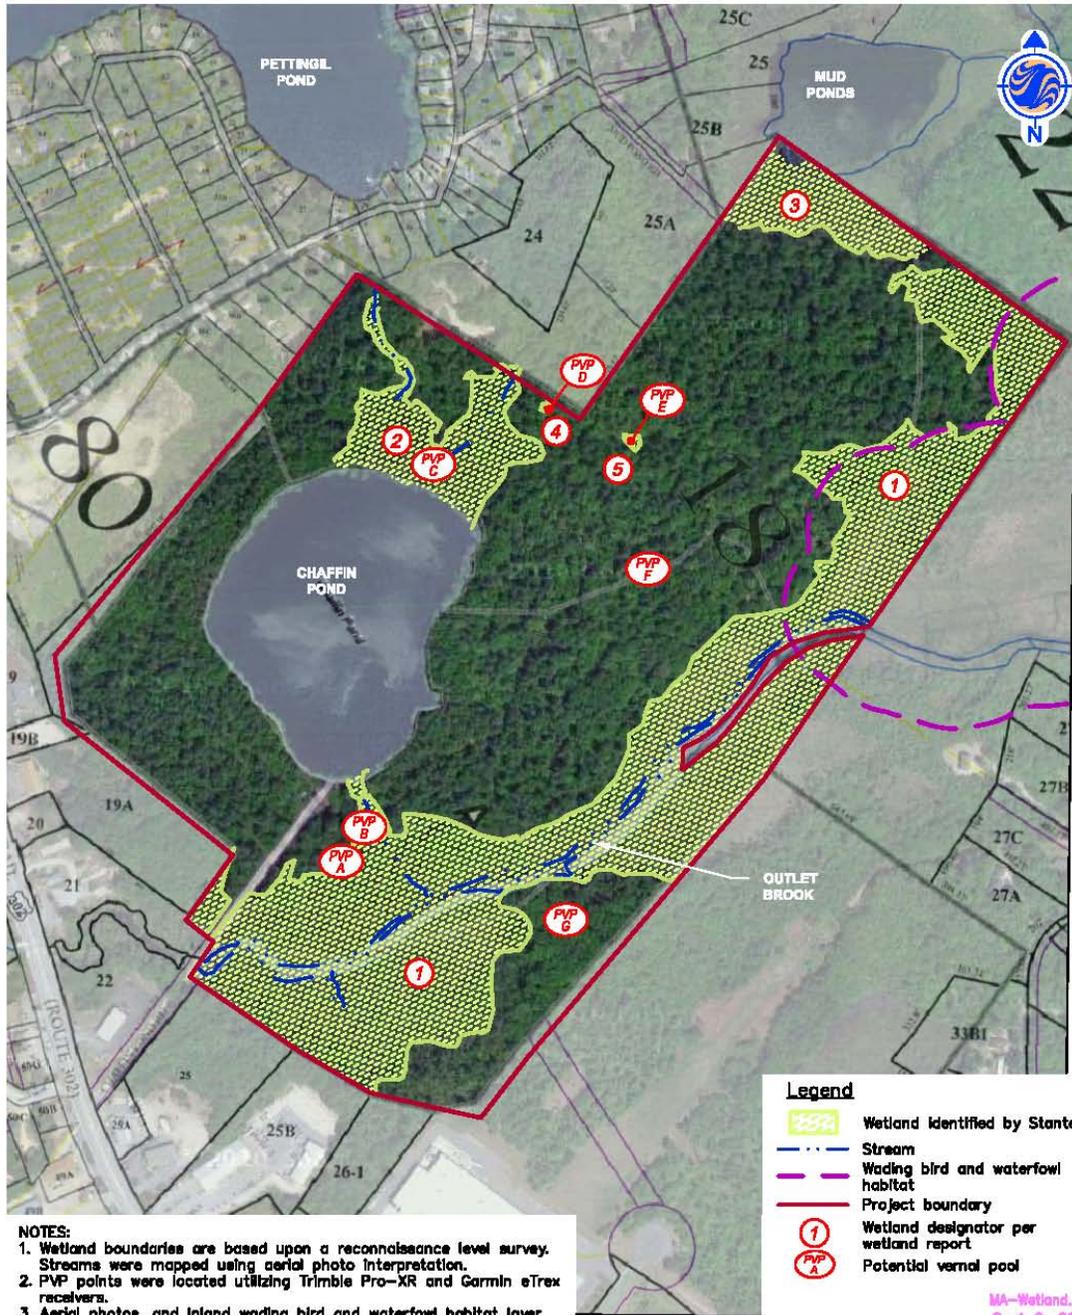
An ecological report completed by Stantec Consulting in 2008 and subsequent addenda in 2009, noted that the Chaffin Pond Preserve (Donnabeth Lippman Park) property is highly valued as a diverse natural resource. The ecology of the site includes approximately 72 acres of oak-pine upland and approximately 51 acres of wetland/stream and pond areas.

**NOTES:**  
 1. Wetland boundaries are based upon a reconnaissance level survey. Streams were mapped using aerial photo interpretation.  
 2. PVP points were located utilizing Trimble Pro-XR and Garmin eTrex receivers.  
 3. Aerial photos, and Inland wading bird and waterfowl habitat layer obtained from MEGIS. Aerial photo date 2003.

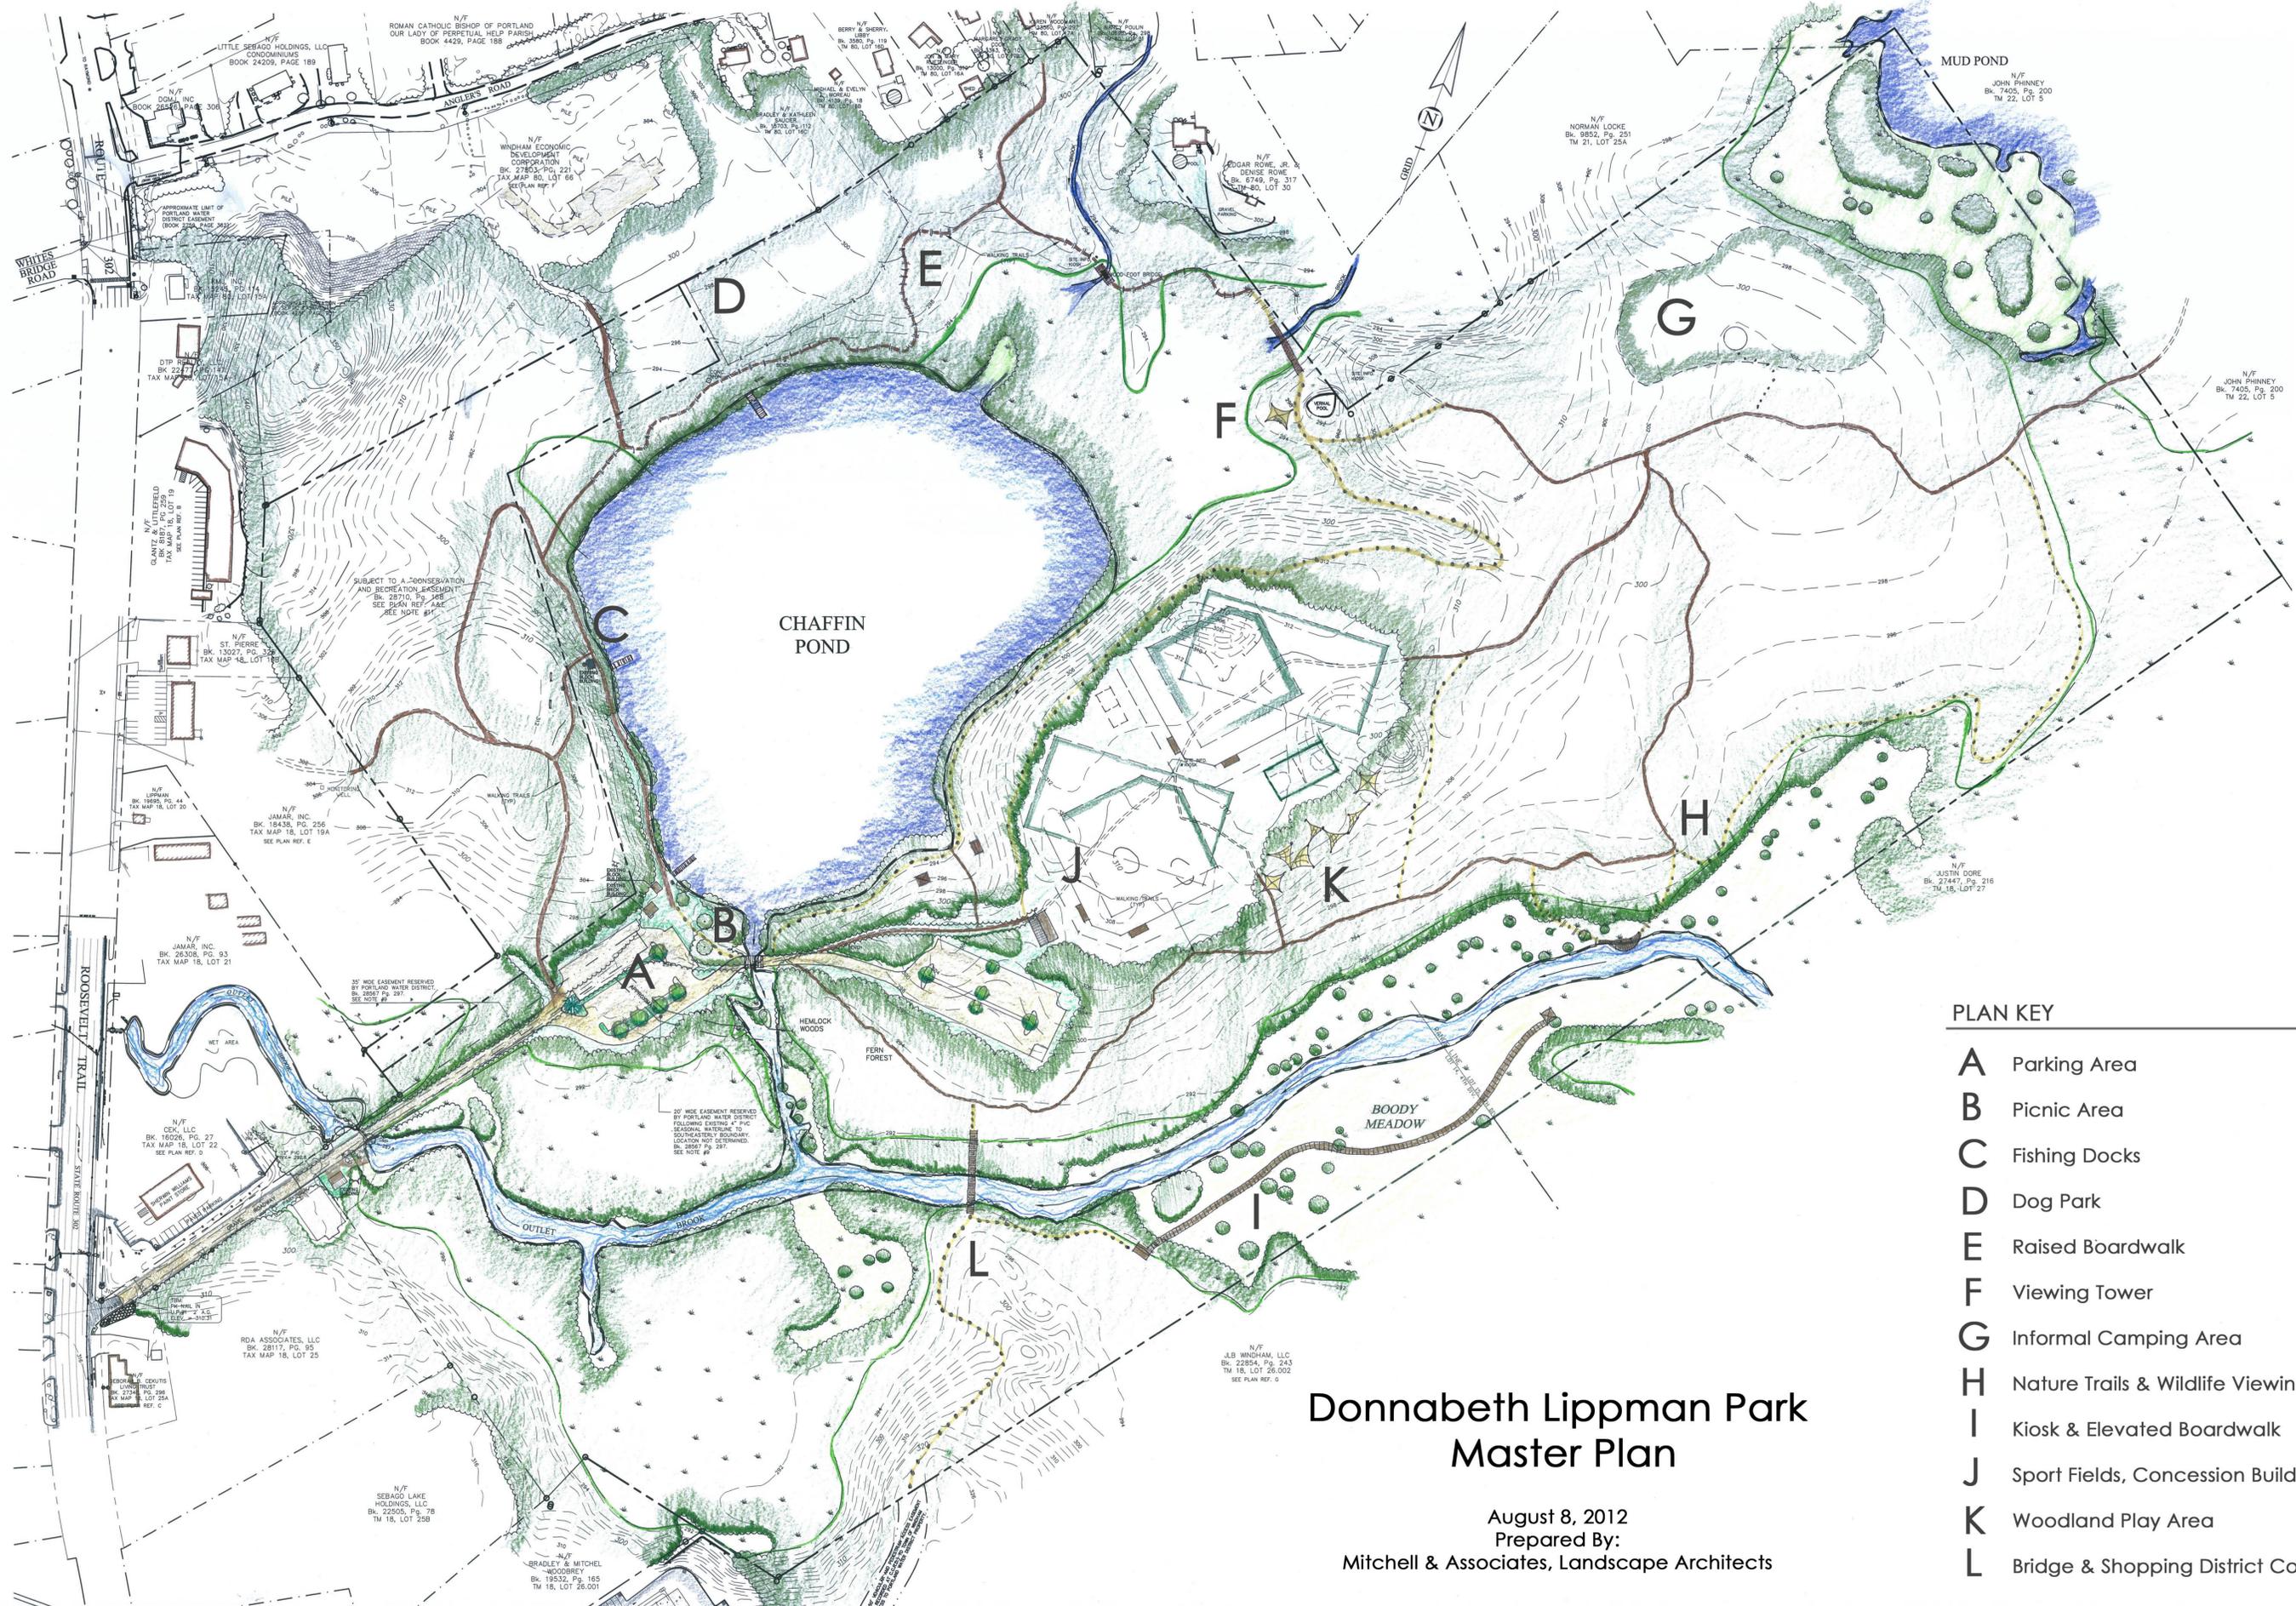
**PLAN KEY**

<b>A</b>	Parking Area
<b>B</b>	Picnic Area
<b>C</b>	Fishing Docks
<b>D</b>	Dog Park
<b>E</b>	Raised Boardwalk
<b>F</b>	Viewing Tower
<b>G</b>	Informal Camping Area
<b>H</b>	Nature Trails & Wildlife Viewing Areas
<b>I</b>	Kiosk & Elevated Boardwalk
<b>J</b>	Sport Fields, Concession Building & Parking
<b>K</b>	Woodland Play Area
<b>L</b>	Bridge & Shopping District Connector

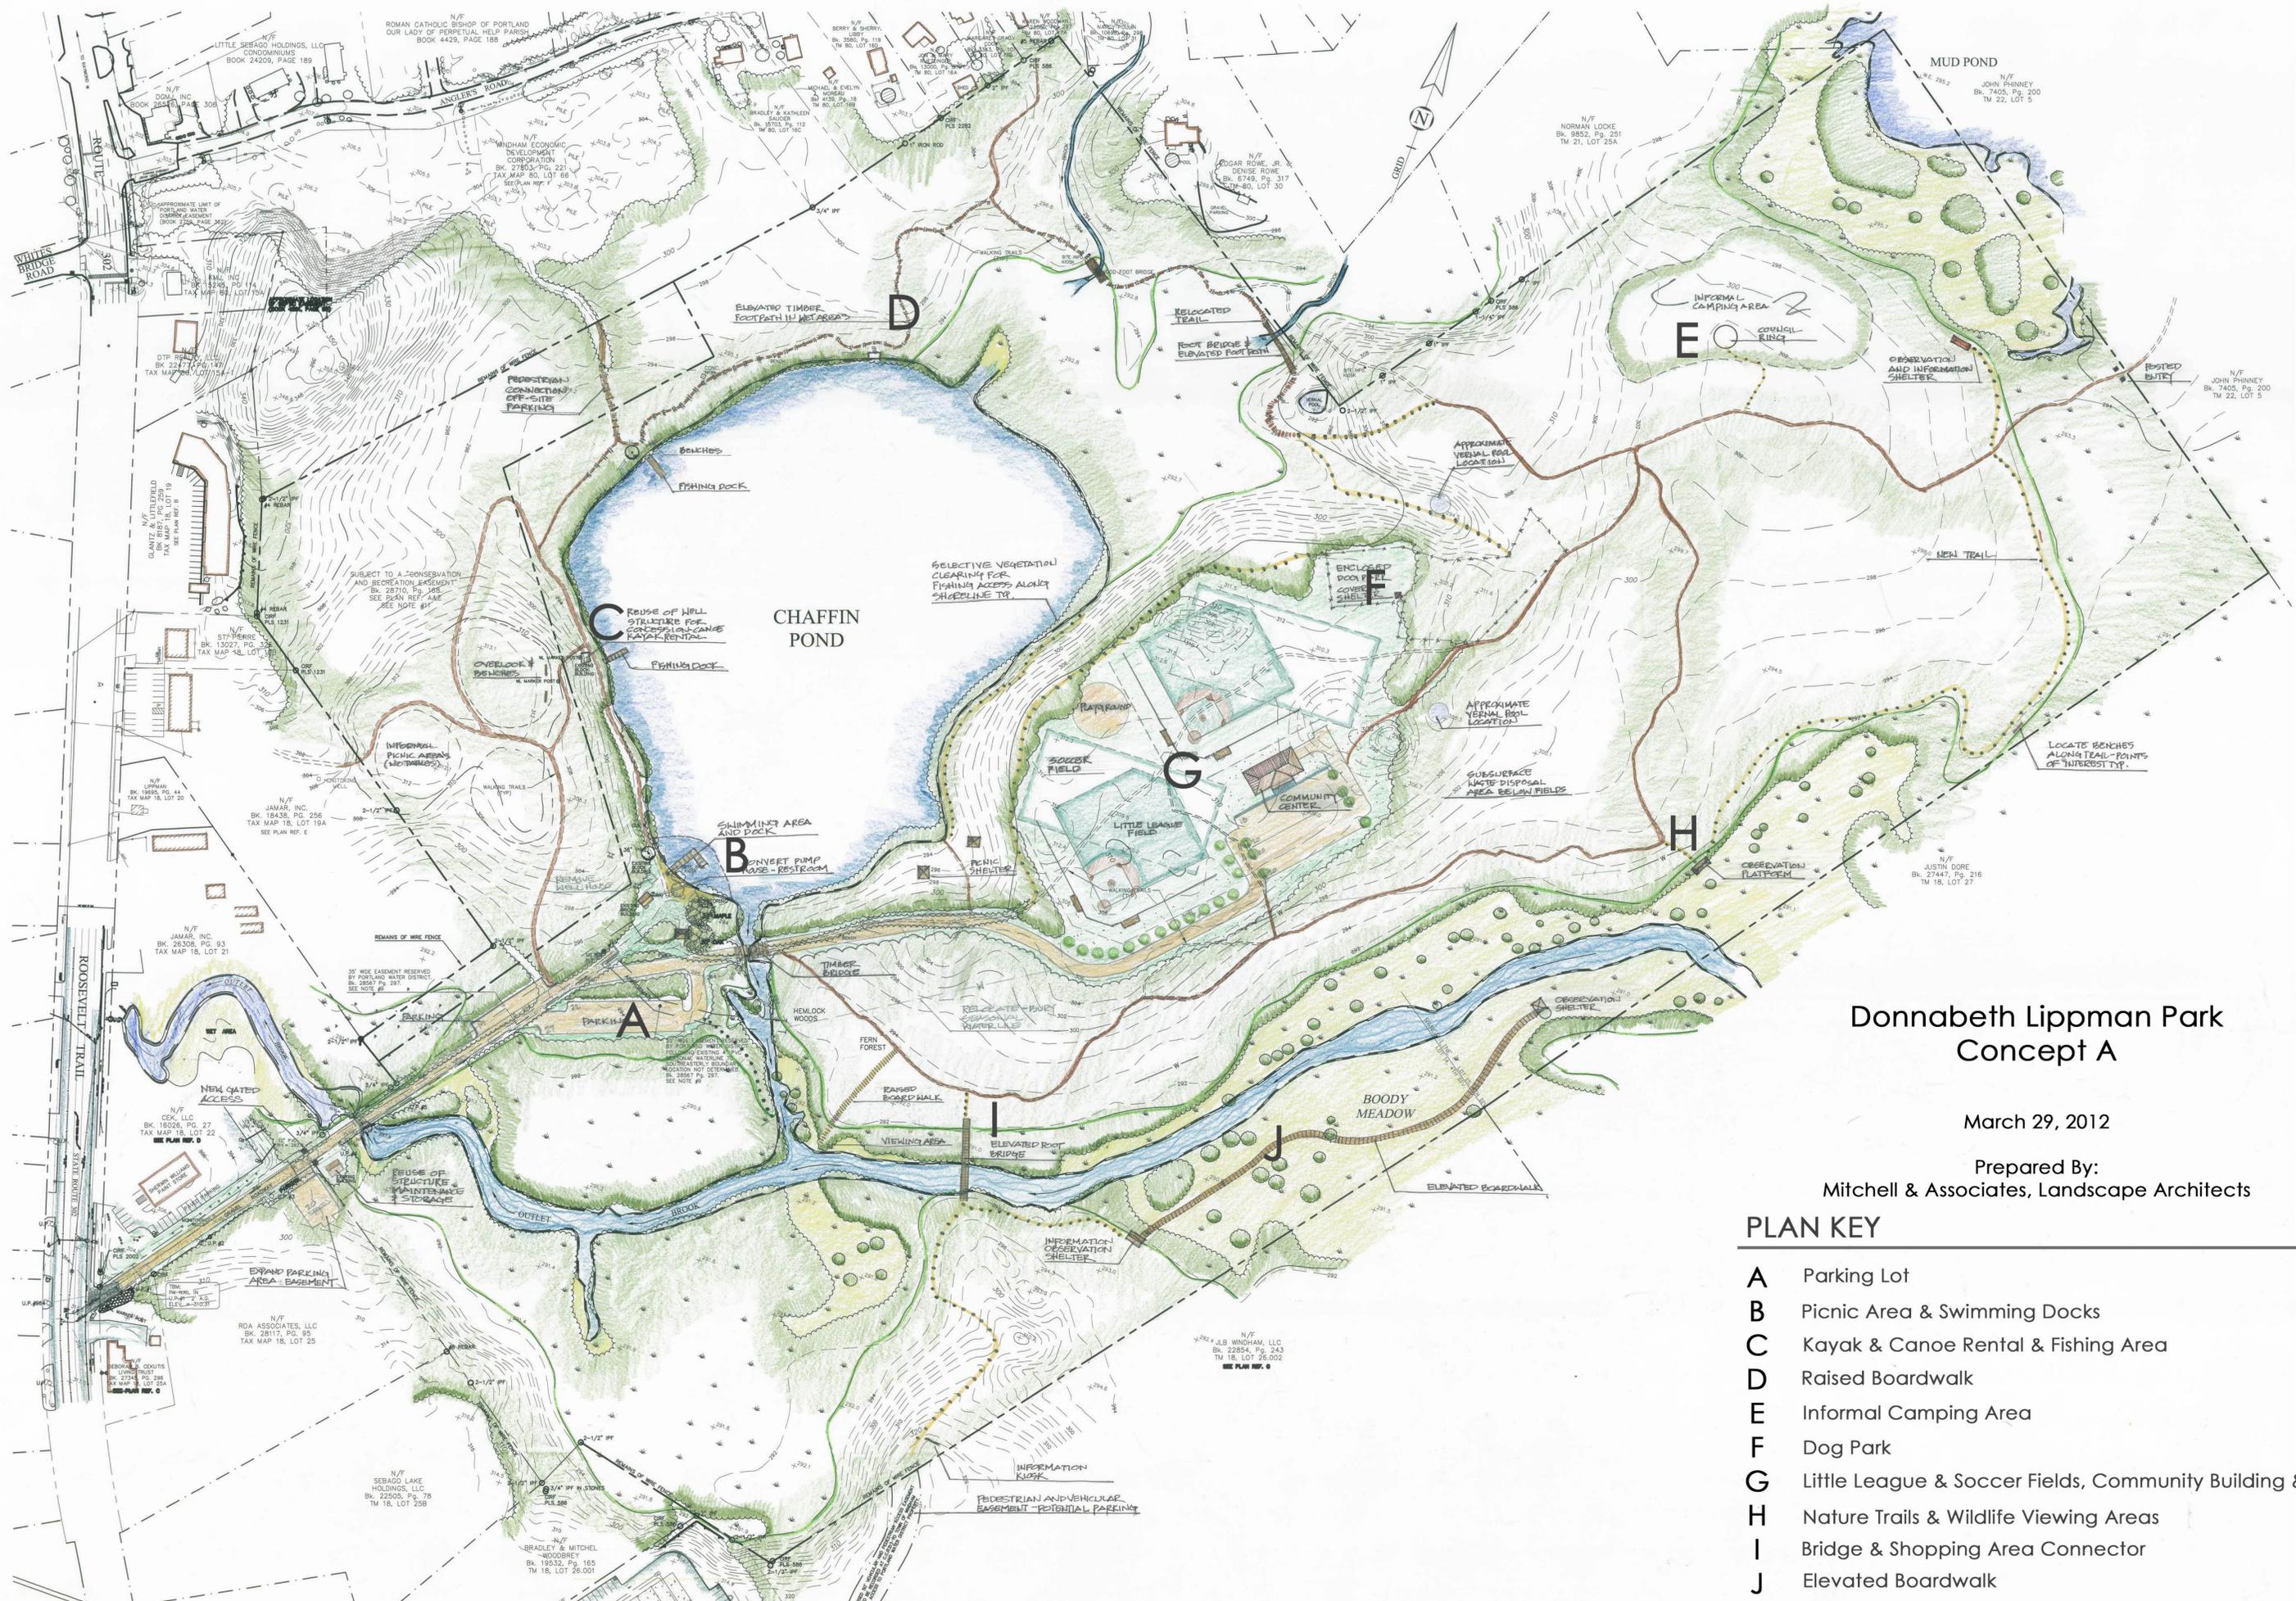
# Donnabeth Lippman Park Concept A

- A** Parking Lot
- B** Picnic Area & Swimming Docks
- C** Kayak & Canoe Rental & Fishing Area
- D** Raised Boardwalk
- E** Informal Camping Area
- F** Dog Park
- G** Little League & Soccer Fields, Community Building & Playground
- H** Nature Trails & Wildlife Viewing Areas
- I** Bridge & Shopping Area Connector
- J** Elevated Boardwalk

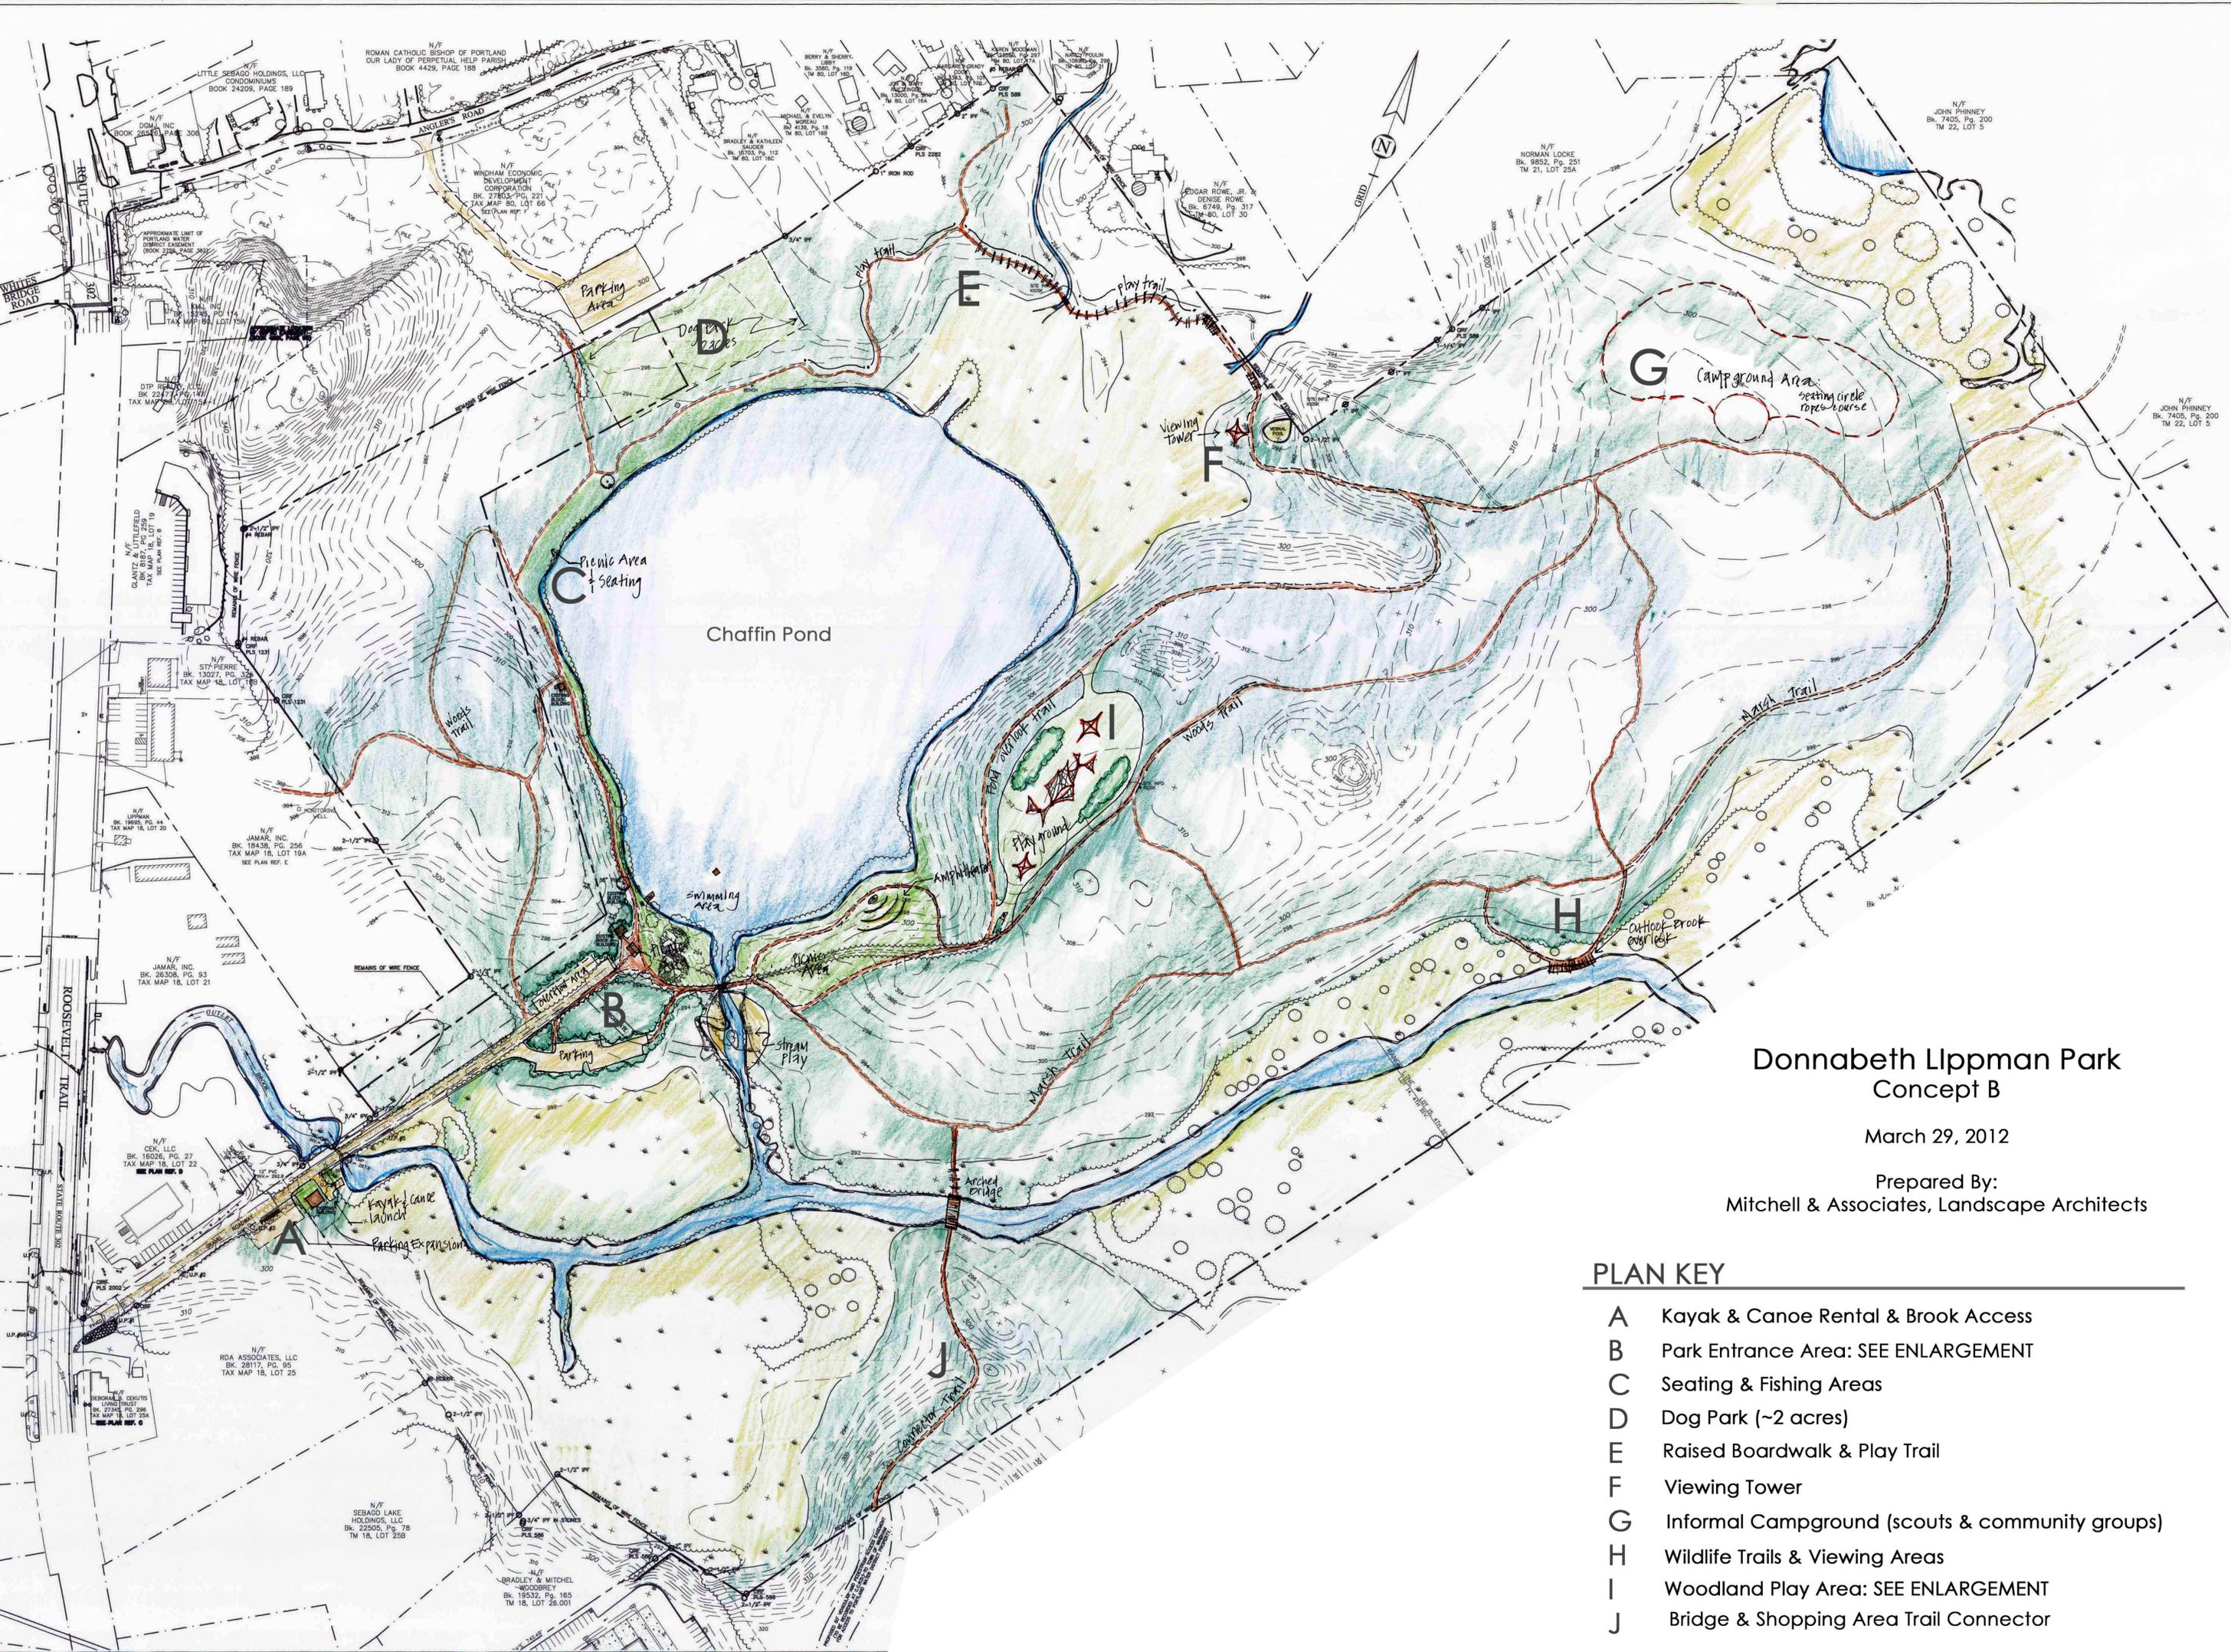
# Donnabeth Lippman Park Concept B

- A Kayak & Canoe Rental & Brook Access
- B Park Entrance Area: SEE ENLARGEMENT
- C Seating & Fishing Areas
- D Dog Park (~2 acres)
- E Raised Boardwalk & Play Trail
- F Viewing Tower
- G Informal Campground (scouts & community groups)
- H Wildlife Trails & Viewing Areas
- I Woodland Play Area: SEE ENLARGEMENT
- J Bridge & Shopping Area Trail Connector

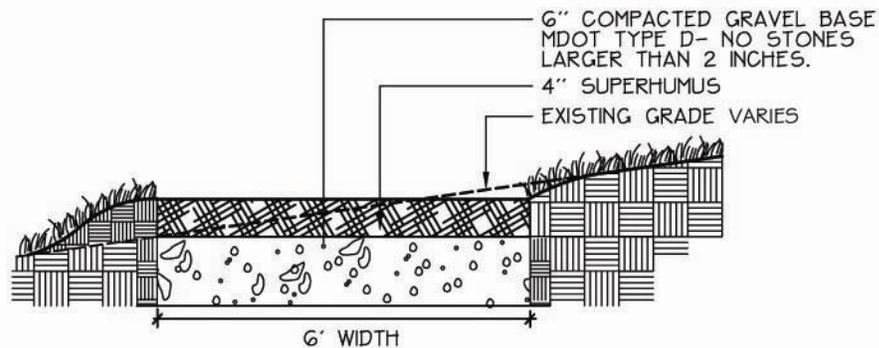
#### WOODLAND PATH

- Limb overhead branching to maintain a minimum ten (10) foot clearance.

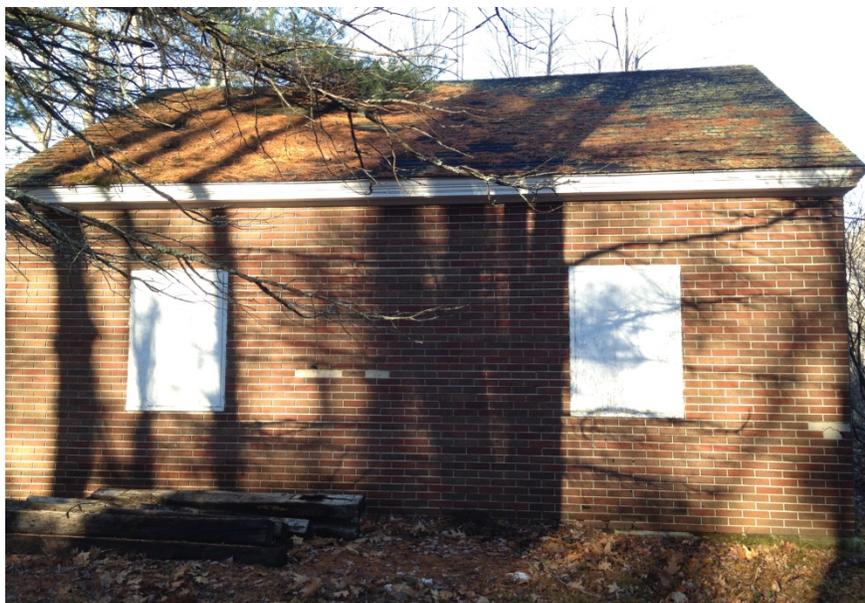
Maintenance Building from the rear. Note brick-like side wall shingles and pine needle covered roof shingles. Both need replacement.

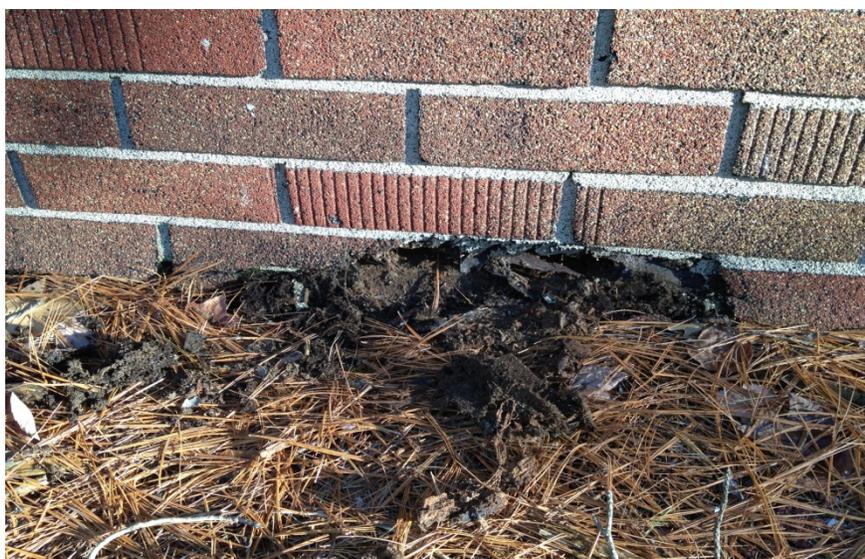
Wood debris located by poking a stick through base of sidewall shingles.

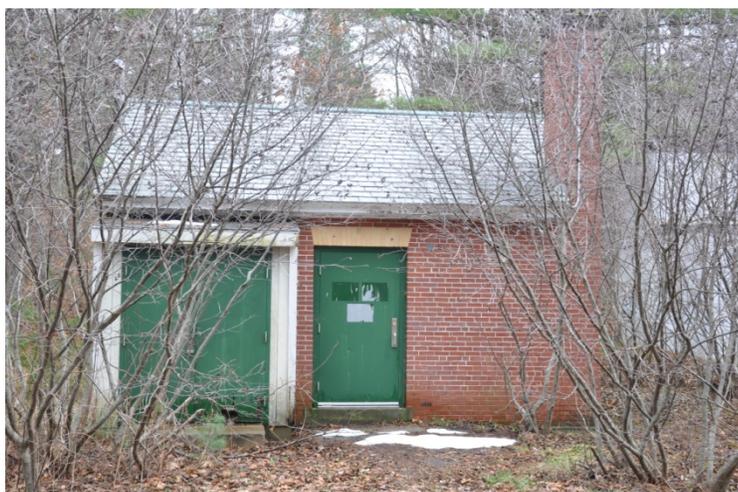
Pump House. Note upward moisture migration at base of wall. This is "rising damp".

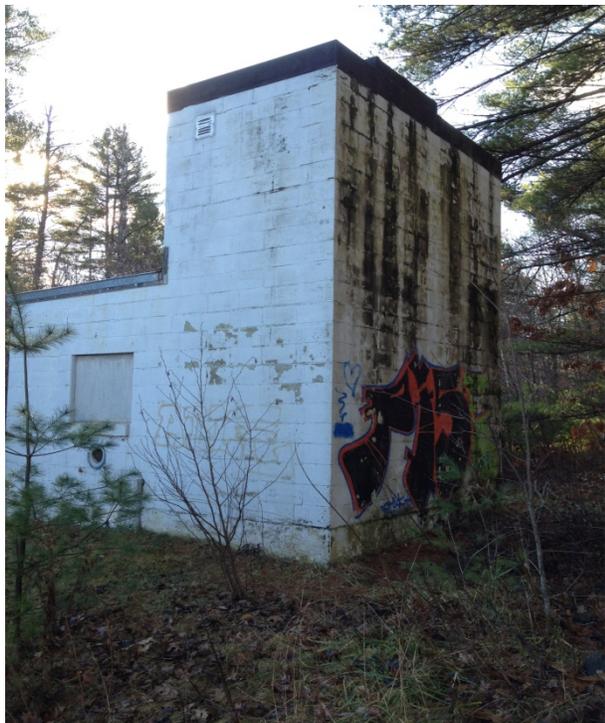
Well House No 1; Note moisture and moss on north and west side. These areas need extensive structural repair.

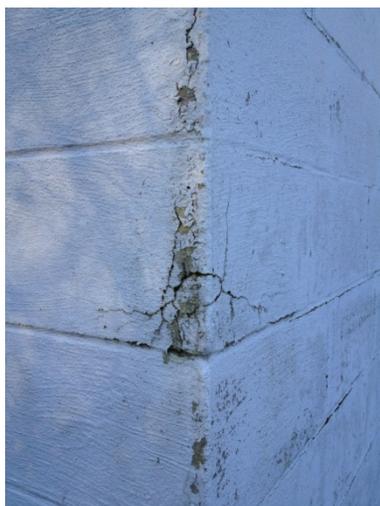
Northwest corner: Freeze-thaw damage to block. Typical condition. Requires removal of damaged areas and replacement, or removal and patching with concrete repair mortar.

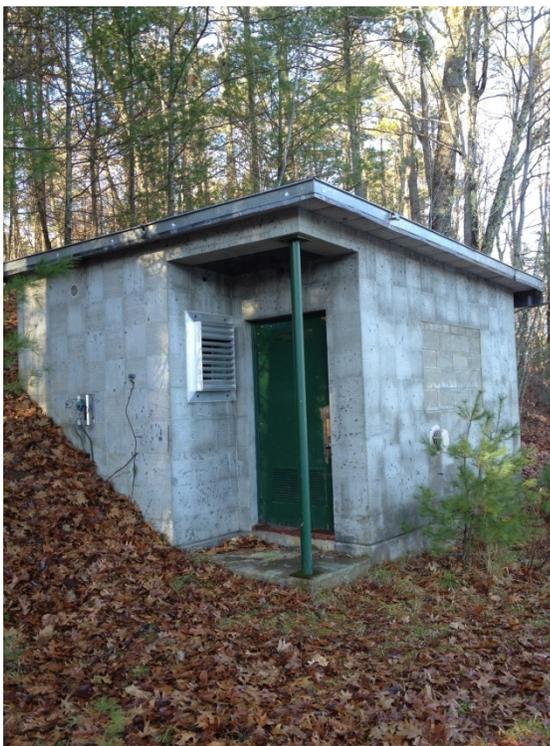
Well House No. 2  
In good Condition
